EFFECT OF DRAINAGE ON THE PERFORMANCE CONCRETE PAVEMENT JOINTS IN MINNESOTA

Background

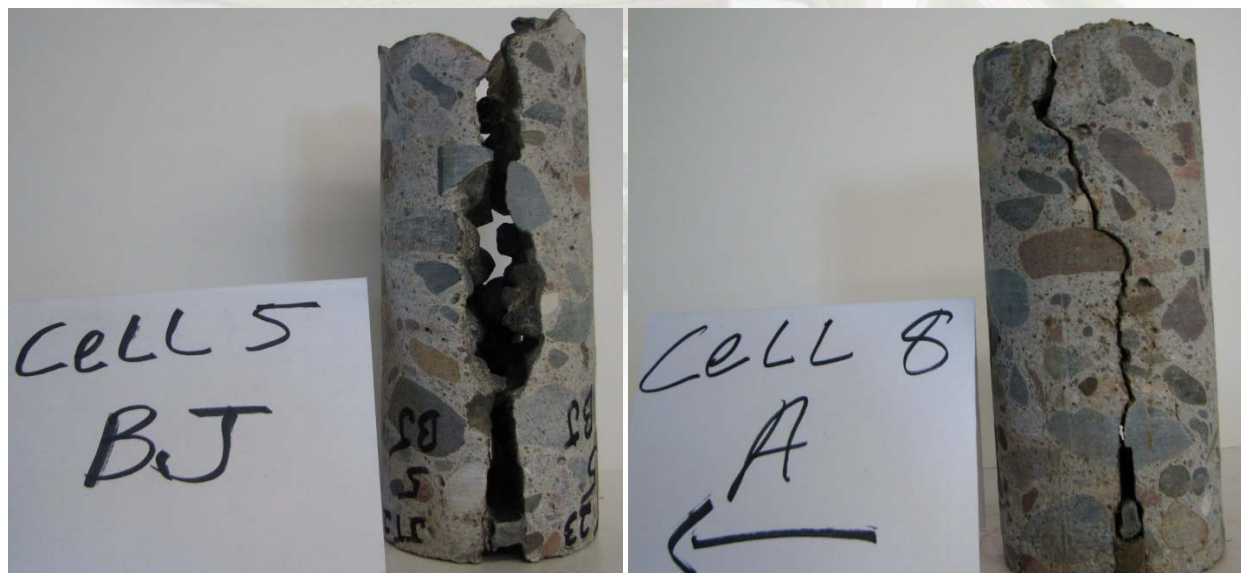
Interestingly, core samples taken over transverse joints for the investigation revealed a unique distress phenomenon for sections constructed over undrained, dense graded, gravel bases. The cores showed that a significant amount of concrete material was missing from the middle section of the joint, with the area of greatest distress just below the saw cut, approximately at mid depth. Cores taken from similar locations in test sections constructed over the more freely draining permeable asphalt stabilized base (PASB) showed virtually no distress. See Photos 1A and 1B for a comparison.

Photo 1. A) Core sample “BJ” (shown inverted) from joint over nondrained gravel base. B) Sample “A” from joint over drainable PASB.

An examination of the potential causes of the unique MnROAD joint distress revealed that a combination of freeze/thaw damage, and more importantly, erosion due to fast traveling trucks, was what ultimately caused the distress. The absence of similar mid-depth erosion in core samples taken from the low volume road test sections at MnROAD (all had undrained gravel bases), confirmed that traffic speed and frequency was likely a factor for the interstate test sections.

Based on these findings, it is recommended that a drainable base layer be used under jointed concrete pavements, with a properly maintained system to remove water.

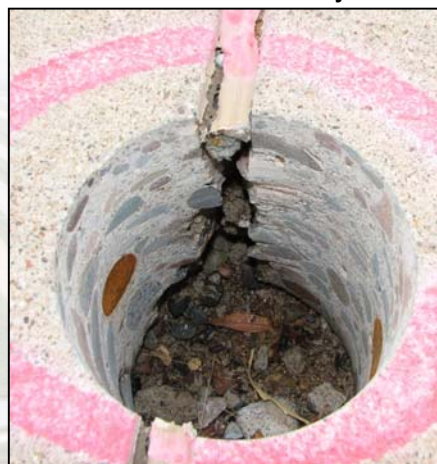
During the investigation, it was revealed that joint sealing can have a significant effect on joint distress. For joints over slowly draining base materials, a core sample taken near a breach in a joint revealed more degradation than a more completely sealed area. See Photo 2.

Photo 2. Effect of breached joint seal.
