**NORTH DAKOTA
DEPARTMENT OF TRANSPORTATION**

Experimental Study MR 97-01

**Practice of Unsealed Joints in New
Portland Cement Concrete Pavements**

Final Evaluation Report

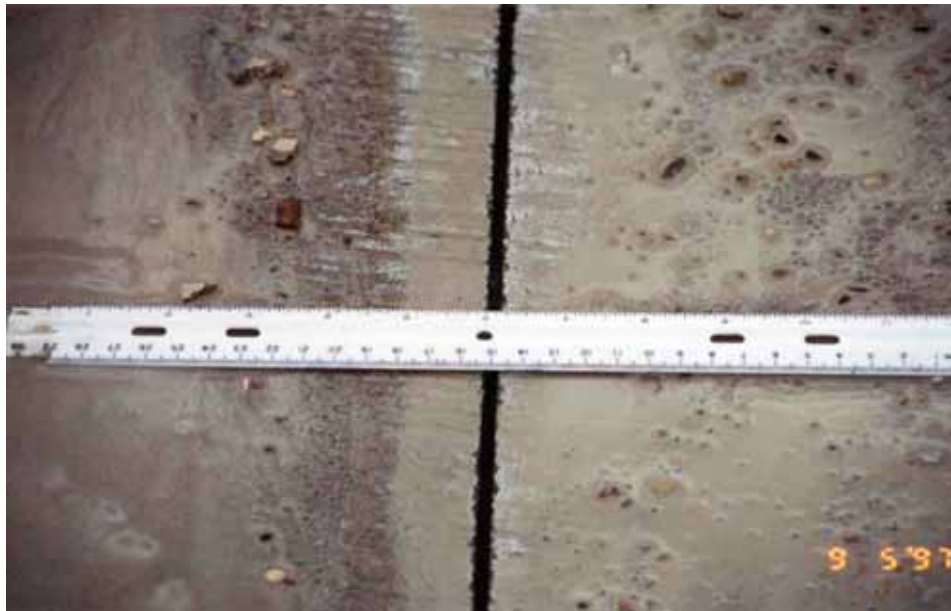
In nearly all cases the contractor managed to produce a finished saw width ranging from 1/8" to 1/4" as shown in photo 3.

Photo 3 - Width of a typical joint.

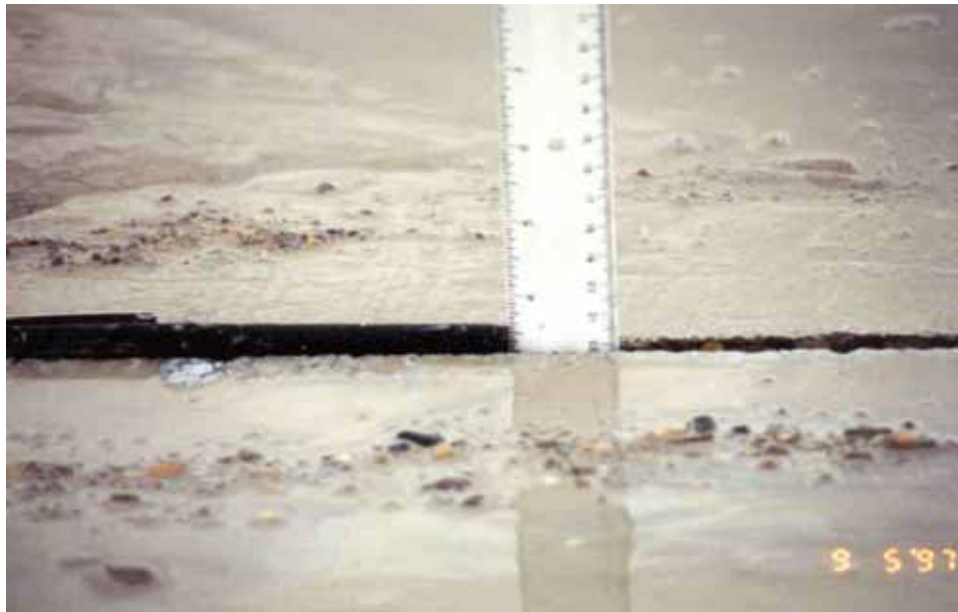
The average saw depth was approximately 3-3/8" deep as shown in photo 4.

As previously mentioned the saw depth on project IM-6-029(027)161 was T/3. The PCC pavement thickness on project IM-6-029(027)161 is 10". During the joint sawing process there were some problems that developed. Photos 5 and 6 depict the sawing process as it commences from right to left. Please note that photos 5 and 6 were taken from the same location. In photo 7, the end saw overlaps an area

Photo 4 - Saw depth is approximately 3-3/8" deep.

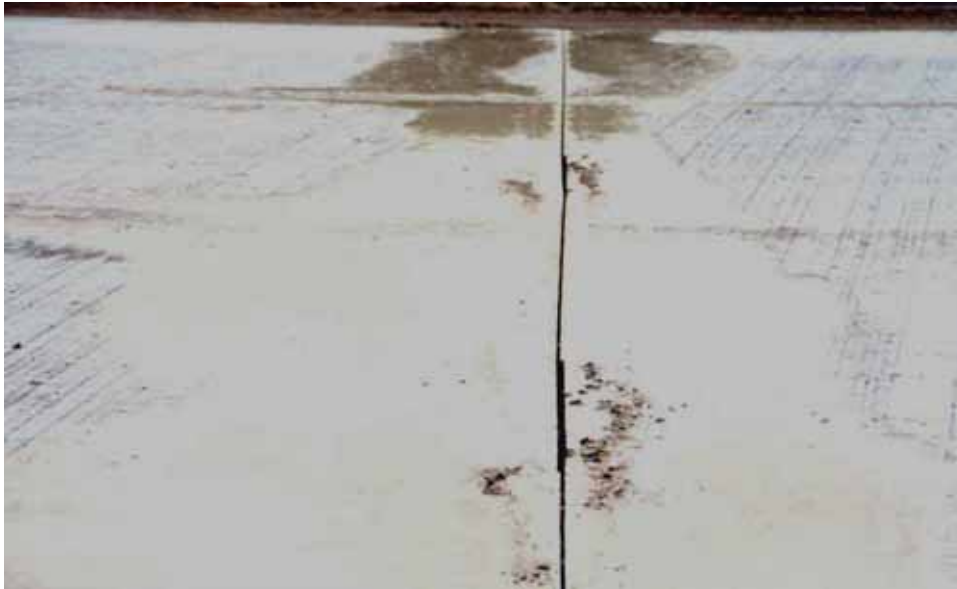
This condition is shown in photo 7. It appears from photo 7 that the individual saws were not completely in line while overlapping one another's cutting path. Notice also in photo 7 that the overlapping is causing medium sized chips to be dug out of the

PCC. The condition depicted in photo 7 has occurred in nearly every joint sawed and is present within each joint as many as three times.

Photo 7 - Extra wide segment caused by the contractors gang saws being out of alignment.

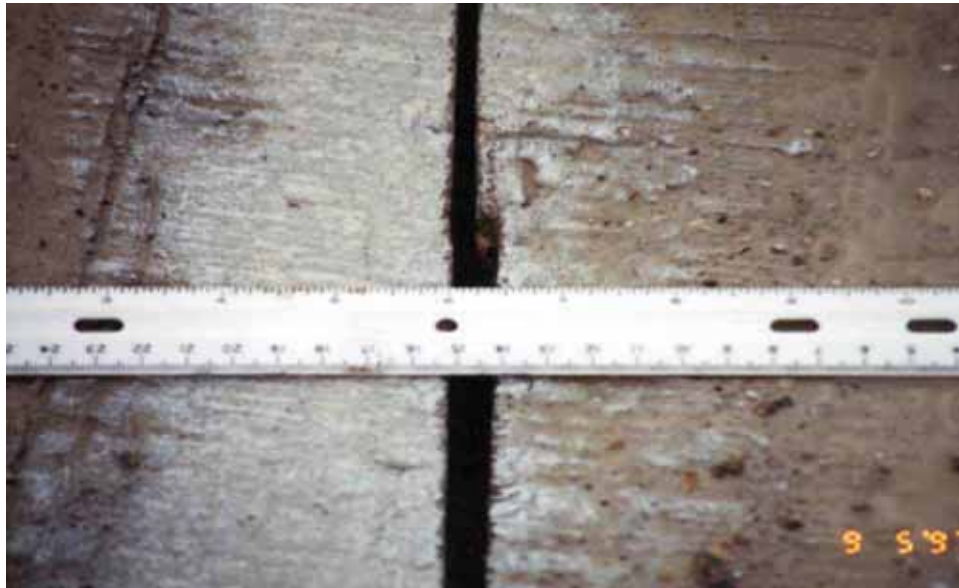
The extra width caused by the overlapping saws has been registered as wide as 1/2", as shown in photo 8. Project engineer Morris Evens (NDDOT) brought the sawing problems to the attention of the contractor.

Making the saw cut as narrow as possible is important because there is less chance for incompressible materials to become lodged between the pavement slabs. This in turn may cause high stress locations when thermal expansion forces the pavement into compression.

Photo 8 - Some of the widened segments are as much as 1/2" wide.

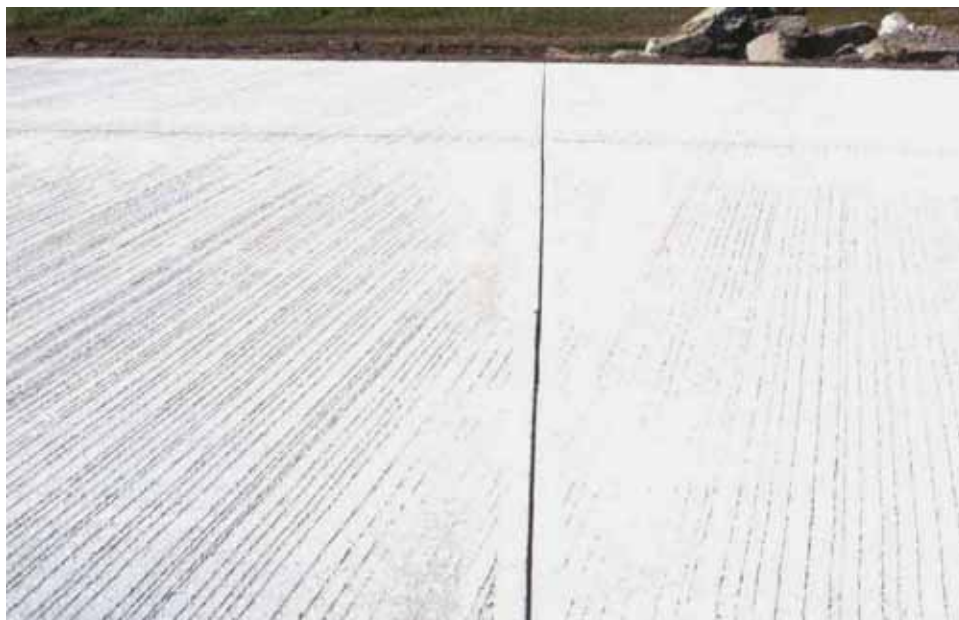
Photo 9 - Typical unsealed joint.

Photo 9 also depicts a view of a segment of the joint that appears wider than the rest of the joint. This extra wide segment of the joint is similar to the condition present in the Grand Forks test section and is present in virtually every joint. Photo 10 depicts a

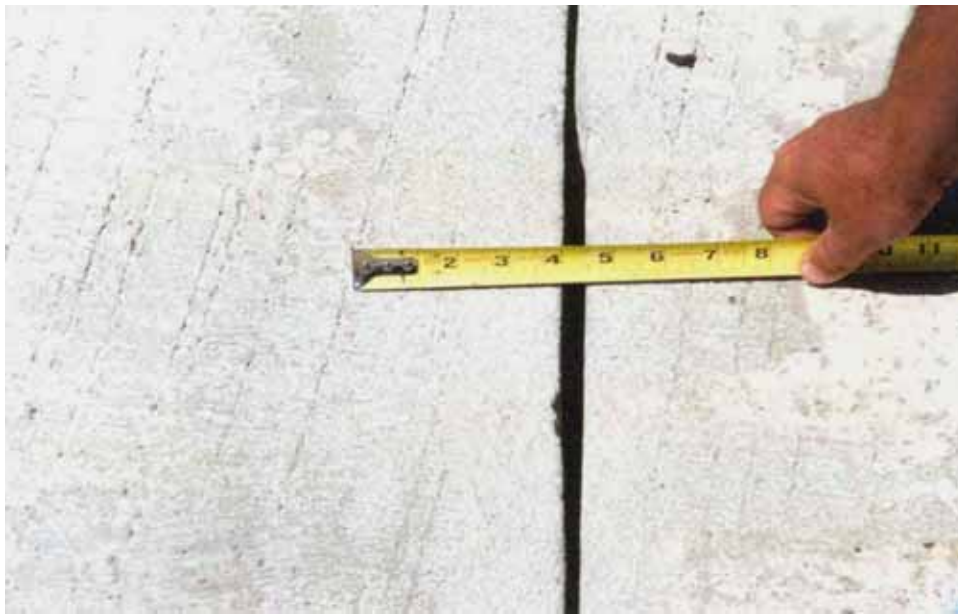
close-up view of one these extra wide segments. It appears that the extra wide segments are also at least 1/2" wide.

Photo 10 - Close-up view of an extra wide segment.

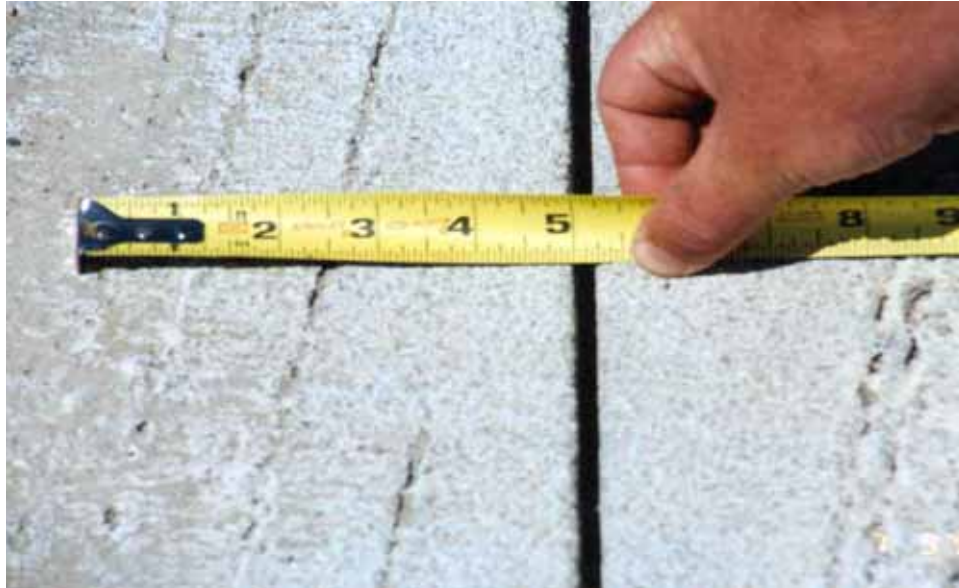
Photo 11 on the next page depicts a close-up view of a portion of an unsealed joint that was sawed correctly. It appears from the measurement taken in photo 11 that the joint is approximately 1/4" in width.

Photo 11 - Close-up view of a portion of an unsealed joint that was sawed correctly.

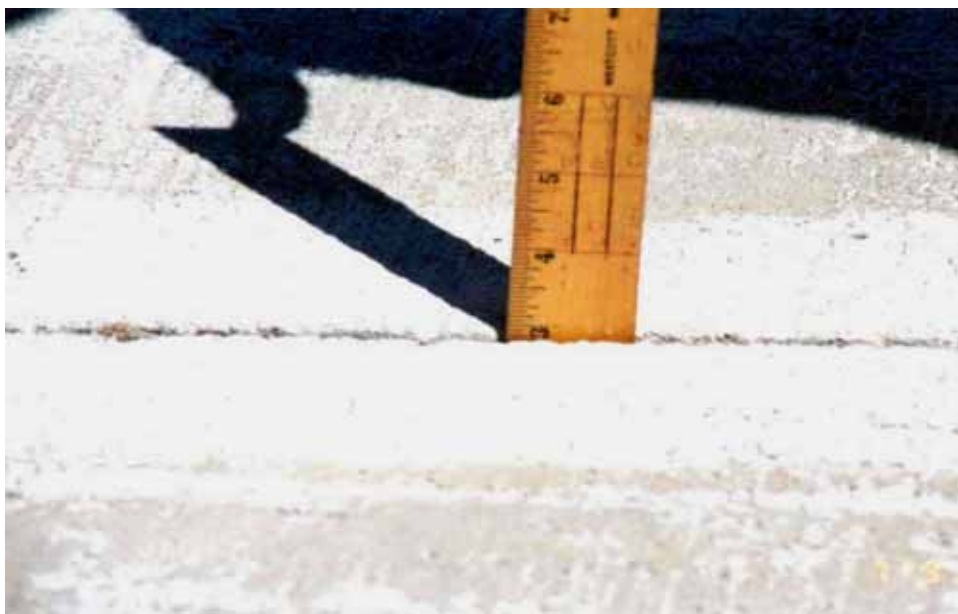
Insufficient depths were also recorded during initial observations at the Jamestown test section. Photo 12 shows the saw depth in the joint in question to be approximately 3". As previously mentioned, the planned saw depth on project IM-2-094(007)256 was T/3. The PCC pavement thickness on project IM-2-094(007)256 is 10".

Photo 12 - Saw depth of joint in question to be approximately 3".

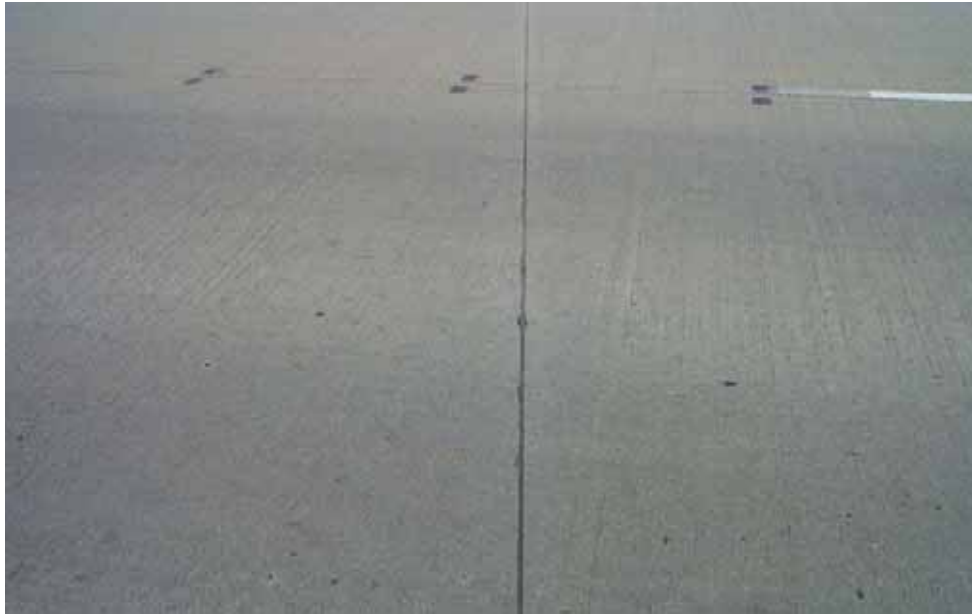
The unsealed joint section spalls tend to be more severe than the sealed joint section. Photo 13 shows a typical spalled joint in the control section. Photo 14 shows a typical spalled joint in the unsealed section and Photo 15 displays a joint with severe spalls.

Photo 13 - Typical spalled joint in the sealed (control) section.

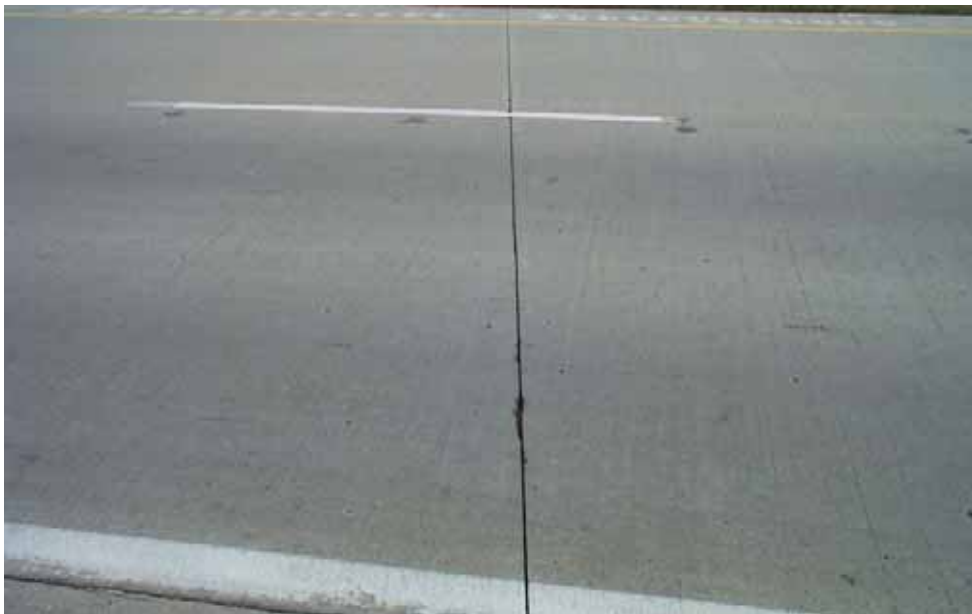
Photo 14 - Typical spalled joint in the unsealed (test) section.

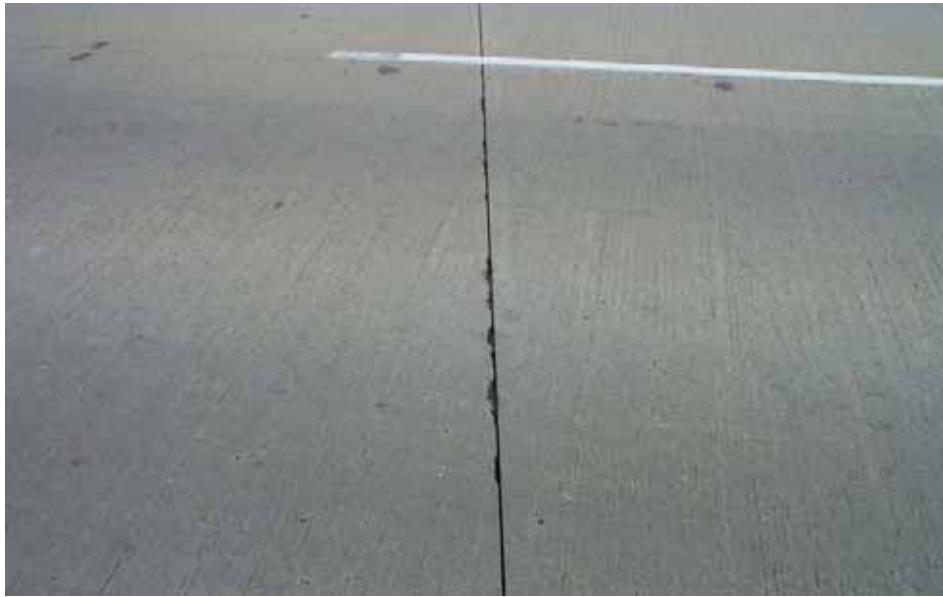
Photo 15 - Most severe spall in unsealed (test) section.

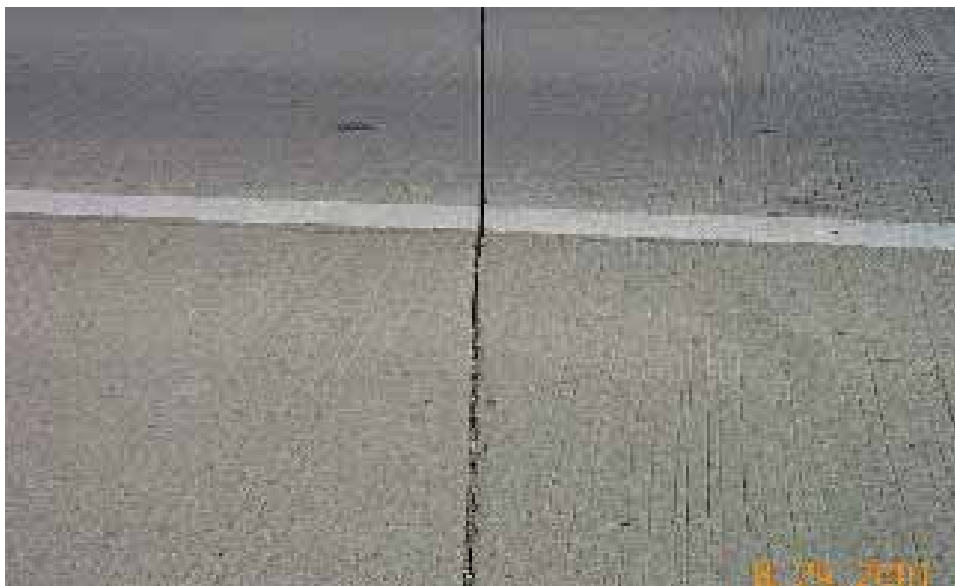
The amount of incompressible material in the unsealed joints are approximately 40-50% filled (depth) in the driving lane. The portion of the joint on the shoulder however, is full of incompressible material. The driving lanes may have remained relatively free of incompressible material due to differential air pressure caused by a vacuum created by the traffic. Photo 16 shows a comparison between the driving lane and the shoulder. This photo is from 2001 and the amount of incompressible material has not changed.

Photo 16 - Incompressible material in shoulder versus driving lane.

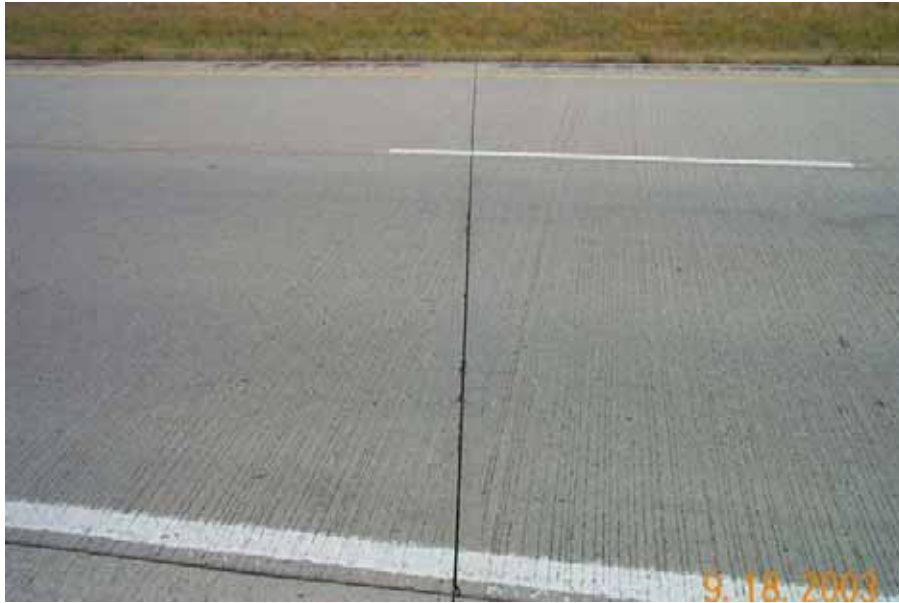
Photo 17 shows a typical spalled joint in the test section and Photo 18 shows a typical spalled joint in the control section. There is a decline in the number of spalled transverse joints, as per the judgment of the evaluator. It appears the numbers of spalled joints are no longer increasing.

Photo 17 - Typical spalled joint in the test section.

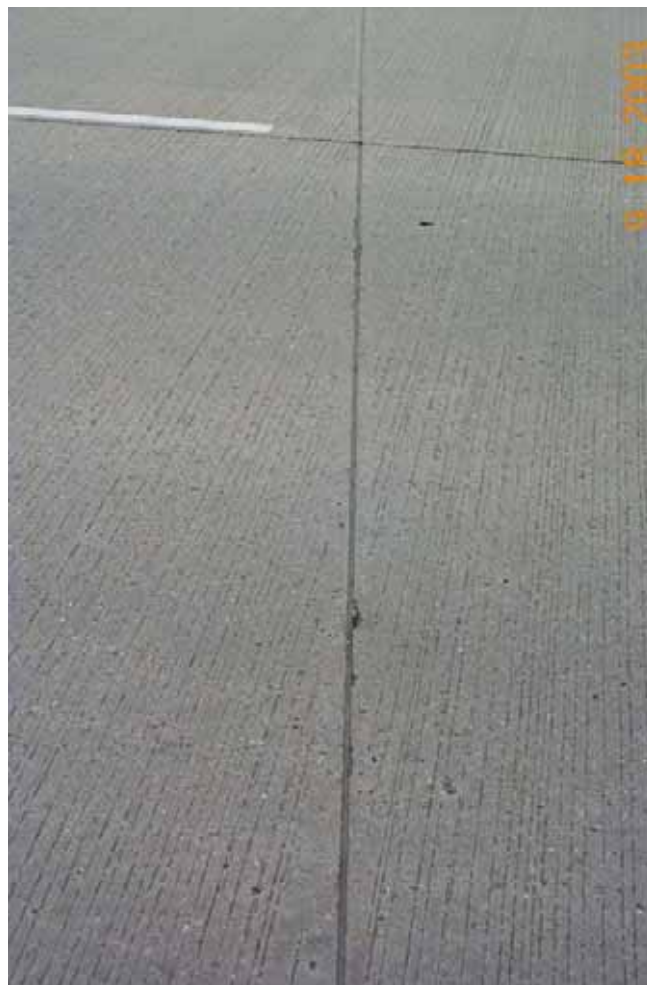
Photo 18 - Typical spalled joint in control section.

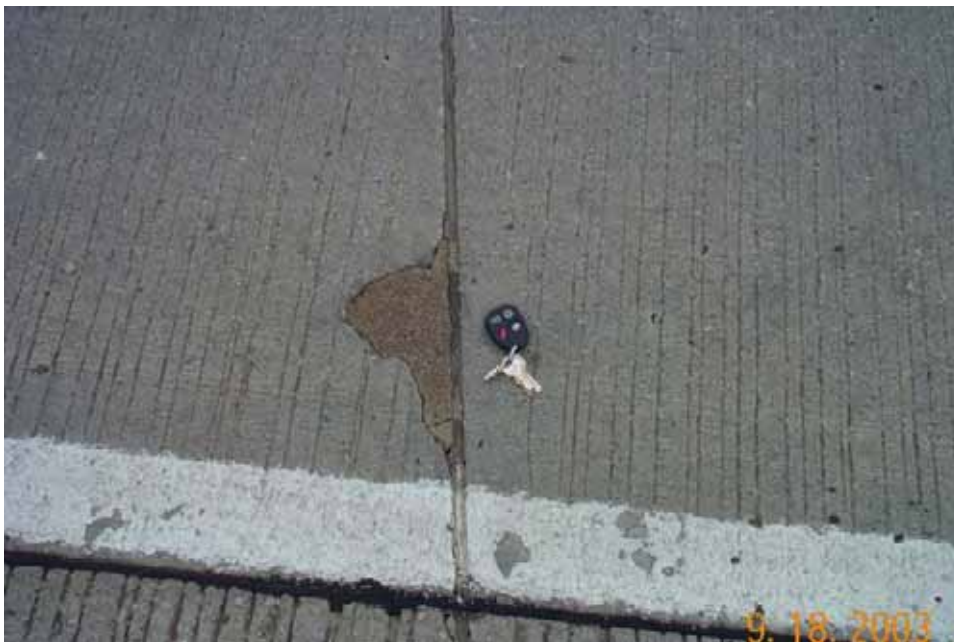
Photo 19 shows an attempt to patch a spalled area in the sealed section. There was also an area in the unsealed section that was repaired as well.

Photo 19 - Attempted spall repair in sealed control section.

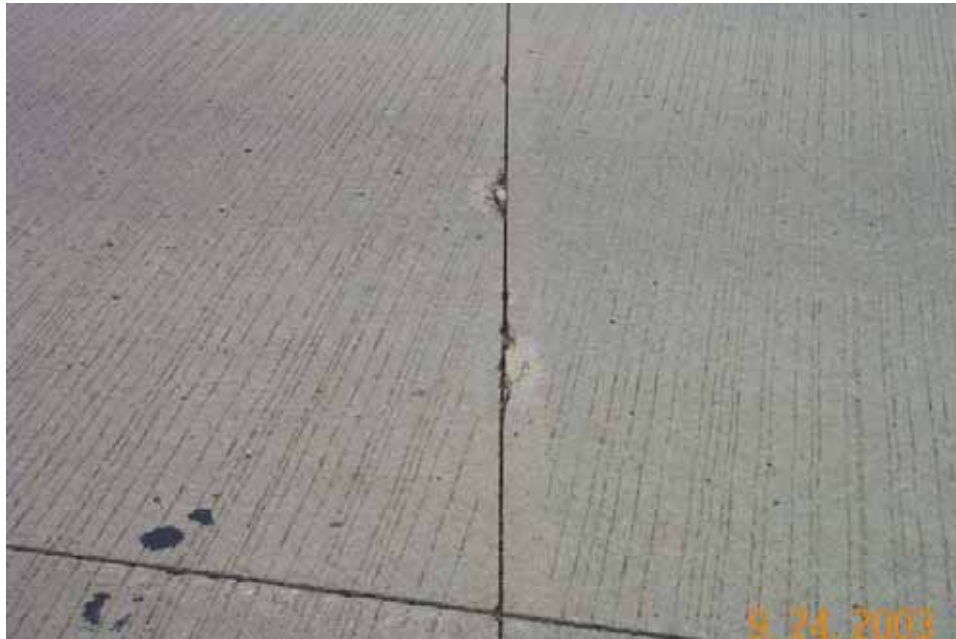
Photo 21 shows a spalled joint in the test section that was attempted to be repaired.

Photo 21 - Attempted spall repair in test section.

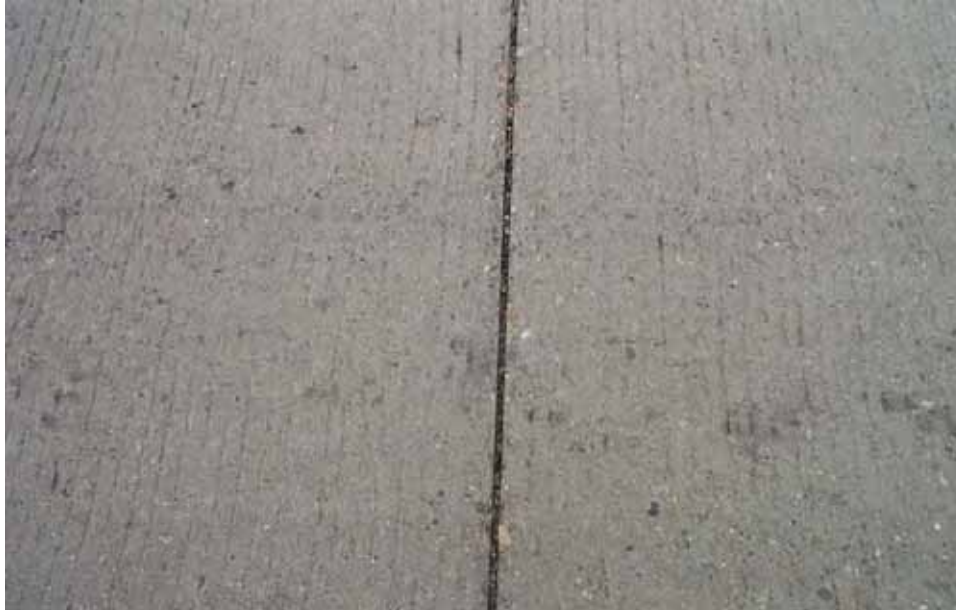
Photo 22 - Incompressible material in an unsealed joint at the shoulders.

Incompressible material has filled the unsealed joints on the shoulders completely. The joints in the driving lane are partially filled with incompressibles ranging from 3/8" to 1 1/8" below the concrete surface. The amount of incompressible material

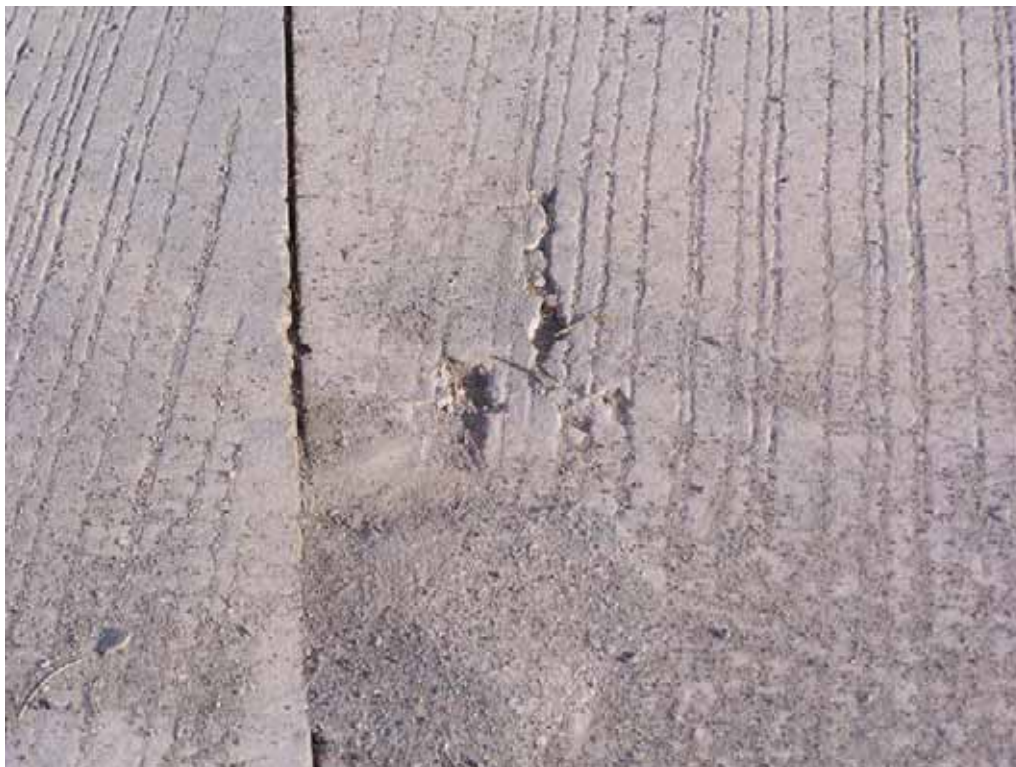
This test section experienced some distresses that the other test sites didn't experience. There is map cracking on the transverse joints in the wheel paths. There is also a longitudinal crack running down the center of the roadway for the majority of the project. These distresses can be seen in Photos 23 & 24.

Photo 23 – Photo of severe map cracking next to transverse joint in “control section”.

These sections of roadway were repaired in the fall of 2005. Materials and Research visited the test section when it was repaired. Sections of the roadway

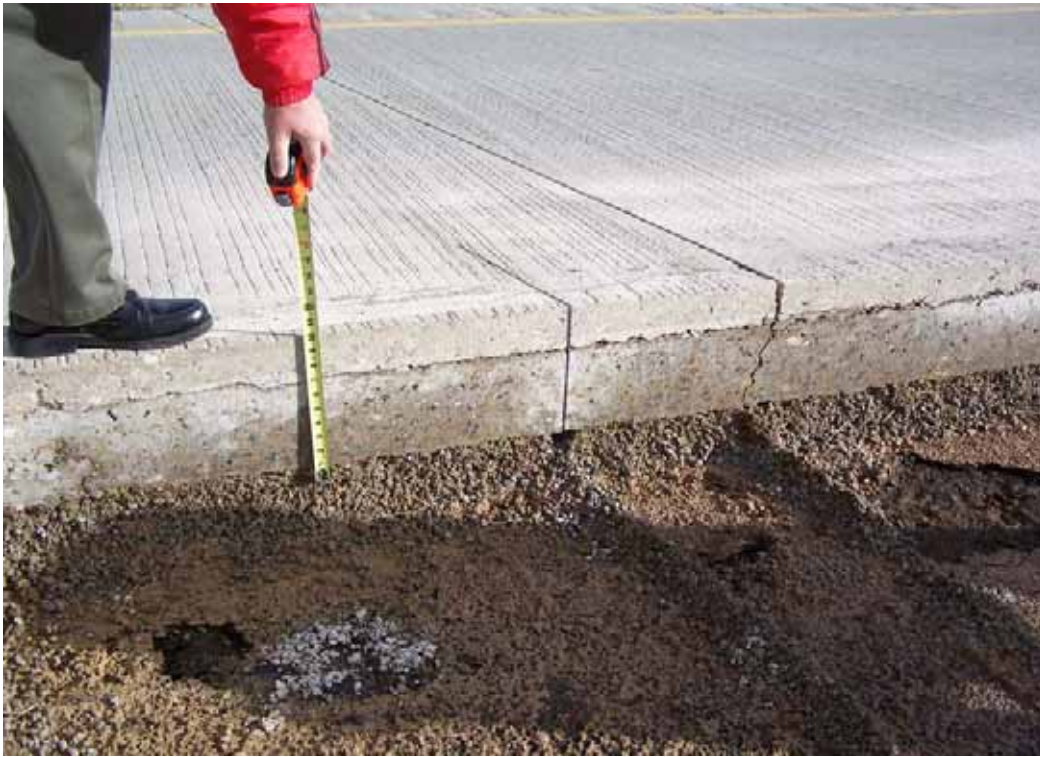
Photo 24 – Photo of longitudinal joint after concrete was removed.

slab depth could be seen. This can be seen in Photo 24 and 25. Cores were taken to be tested by American Petrographic Services, Inc. Samples from these cores were taken at different depths of the concrete. Their testing reported that the cause of the deterioration appears to be due to inconsistencies in the entrained air void system throughout the concrete. They reported that in general they observed lower entrained air content volumes in the upper portions of the concrete. Note the delaminated condition of the pavement section, as depicted in photo 24 and 25. See Appendix A to review report from American Petrographic Services, Inc.

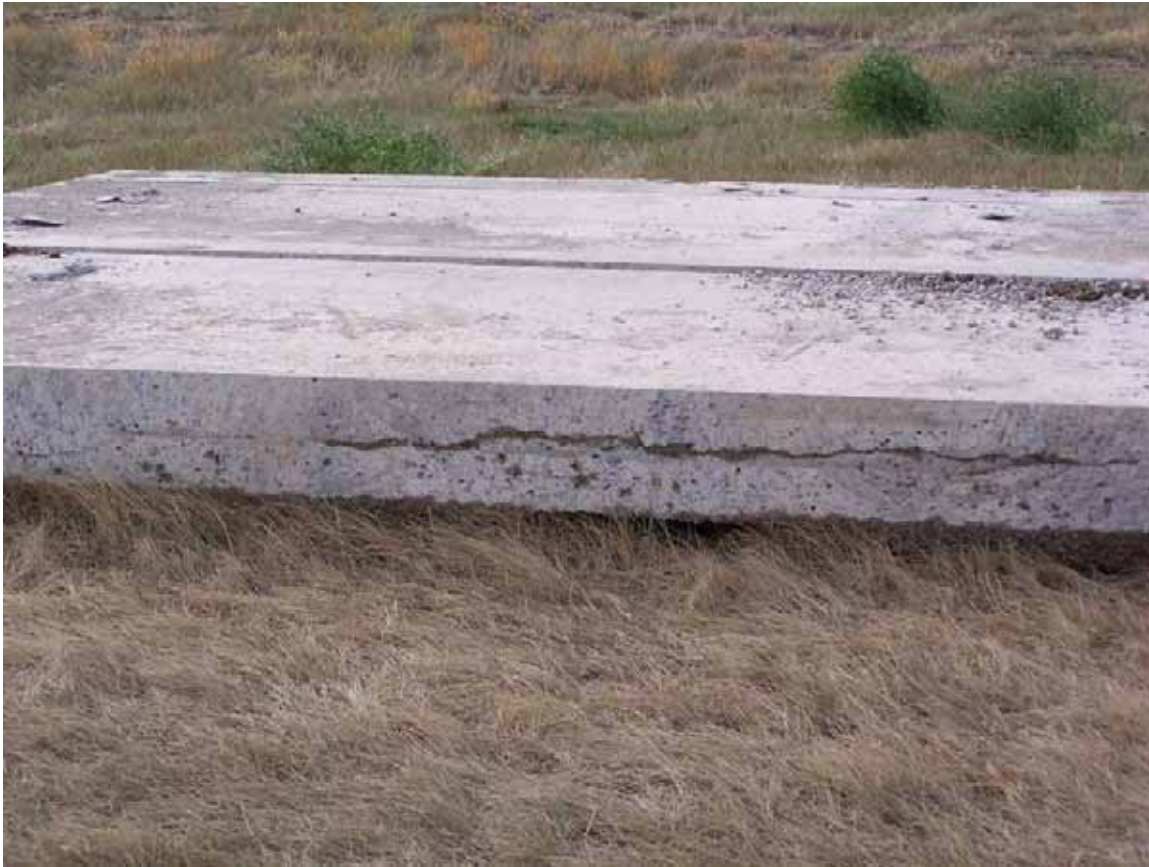
Photo 25 – Photo of crack running transversely in the center of a pavement section removed from roadway.

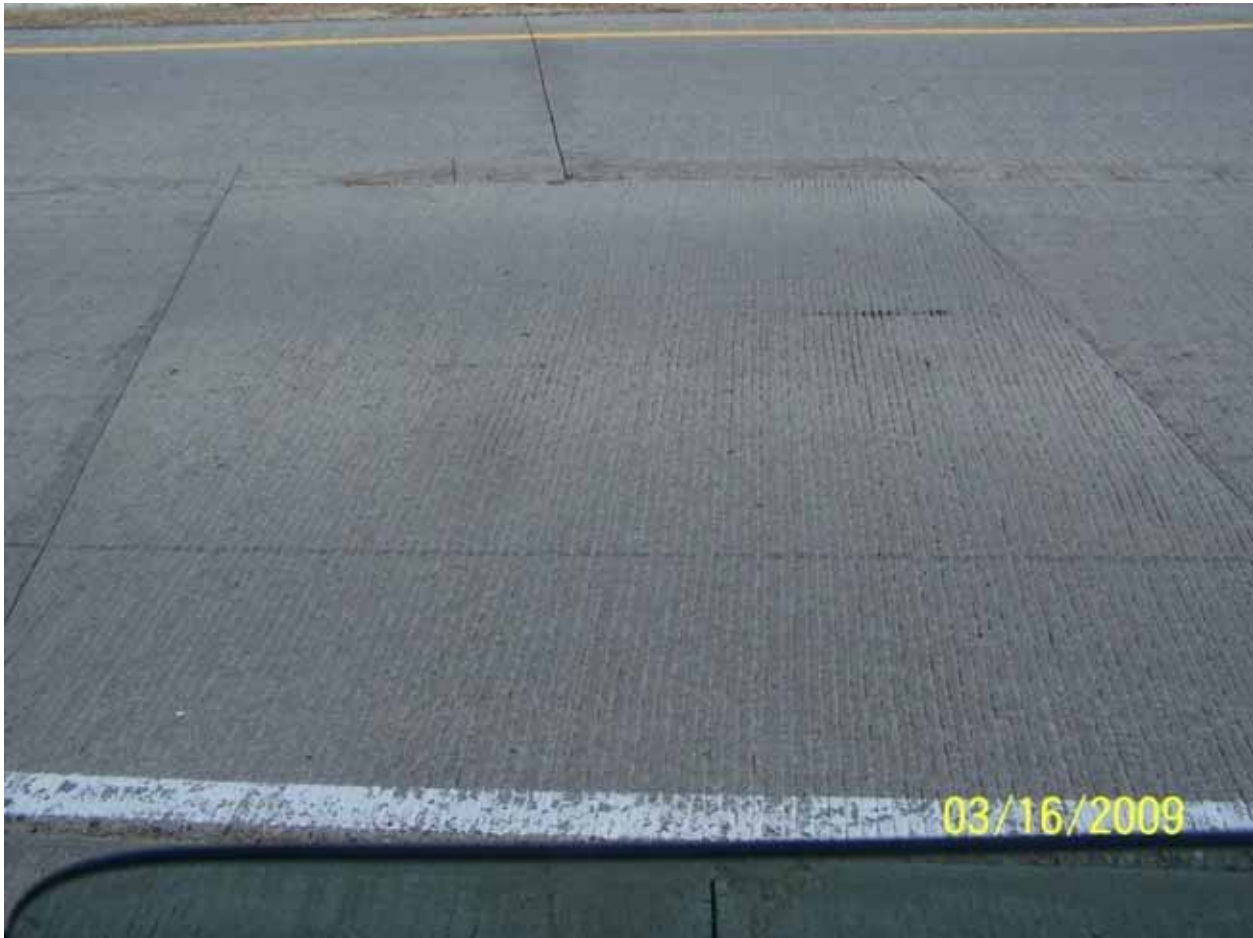
Photo 26 – Photo of repaired joint.

This site was not evaluated for transverse joint spalling or longitudinal joints spalling after the pavement was repaired in 2005, once the original joints are now gone. Table 8 displays the spall results from 2005. A photo of a repaired joint can be seen in Photo 26.

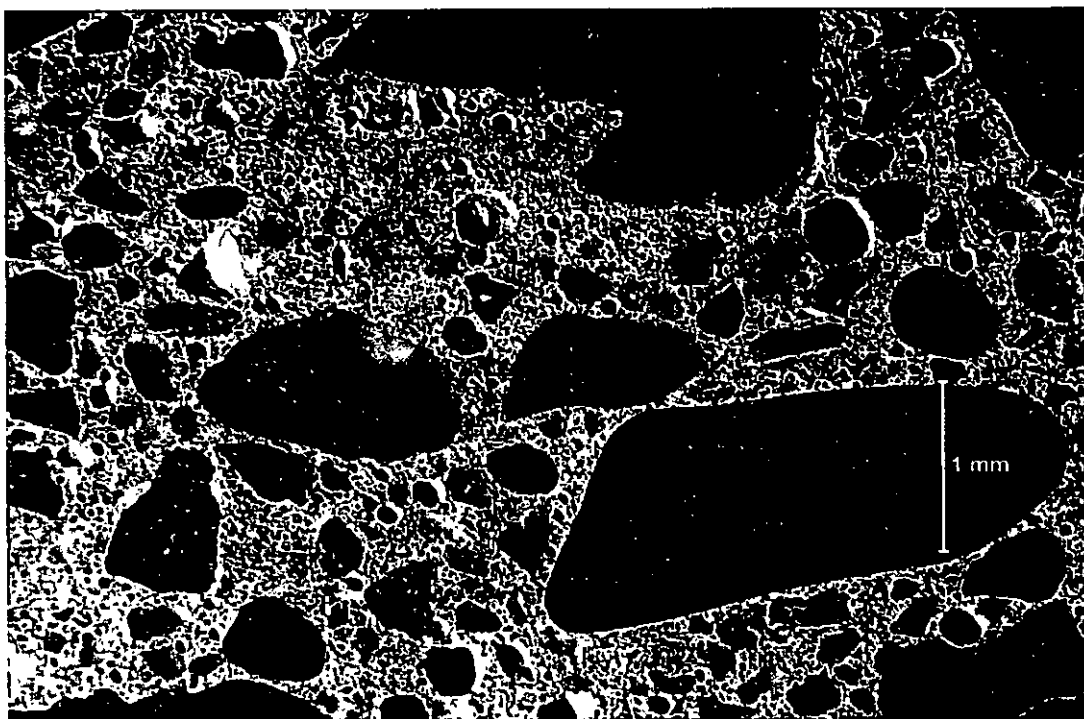
SAMPLE ID: 1 DESCRIPTION: Overall hardened air content is 4.4% in the top 3" of the sample. Image is from 0.25" depth.
