Joint Sealant Field Performance – Ten Year Evaluation

The field phase was initiated in June 1991 at Fairchild Air Force Base near Spokane, WA. The focus of this effort was to determine the field performance of field molded sealants (including improved materials versus commercially available sealants), and if field performance could be improved by changing the sealant installation geometry. Thirteen different field-molded sealants were installed and their field performance monitored at different times over a 10-year period. The evaluations indicated that two of the hot-applied, asphalt-based sealants, four of the silicone-based sealants, and one of the coal tar-based sealants had live expectancies of greater than 10 years. The improved JFR and non-JFR sealants exhibited better field performance than the standard hot-applied sealants included in the evaluation.

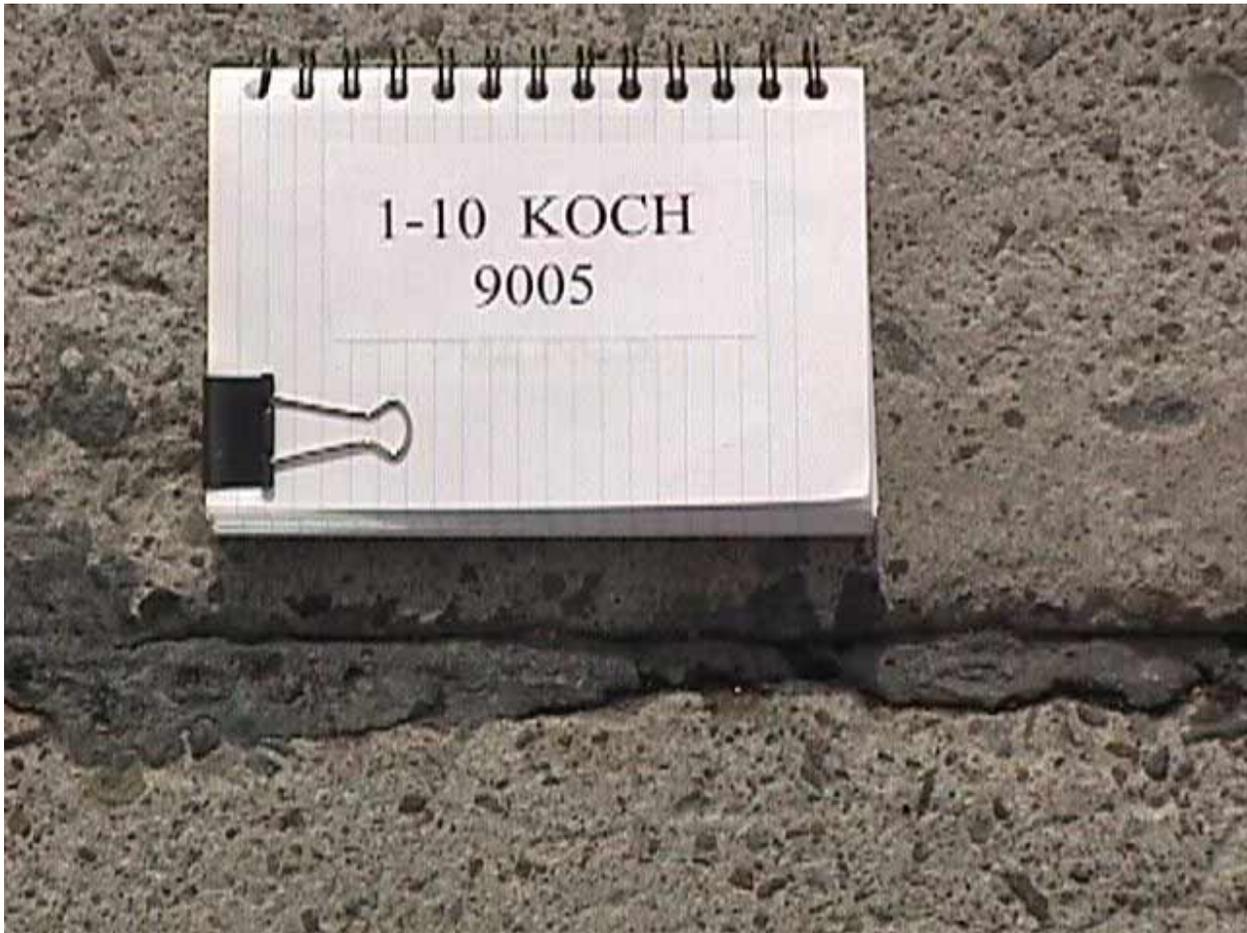
Although the overall performance rating was similar, the two different types of sealant did exhibit different failure modes. The primary mode of failure associated with the asphalt-based sealant sections was adhesive loss. The sealant lost bond with the concrete joint face thus allowing water to penetrate the pavement structure as shown in Figure 2. The primary failure mode associated with the silicone-based sealant sections was also adhesive loss. However, the failure was not a true adhesive loss, instead the sealant appeared to create spalling of the concrete as shown in Figure 3. Based on these two failure modes, it would appear for this application that the asphalt-based materials would be more desirable because the silicone materials appear to be pulling the concrete apart.

FIGURE 2 Adhesive Failure of The Asphalt-Based Sealant

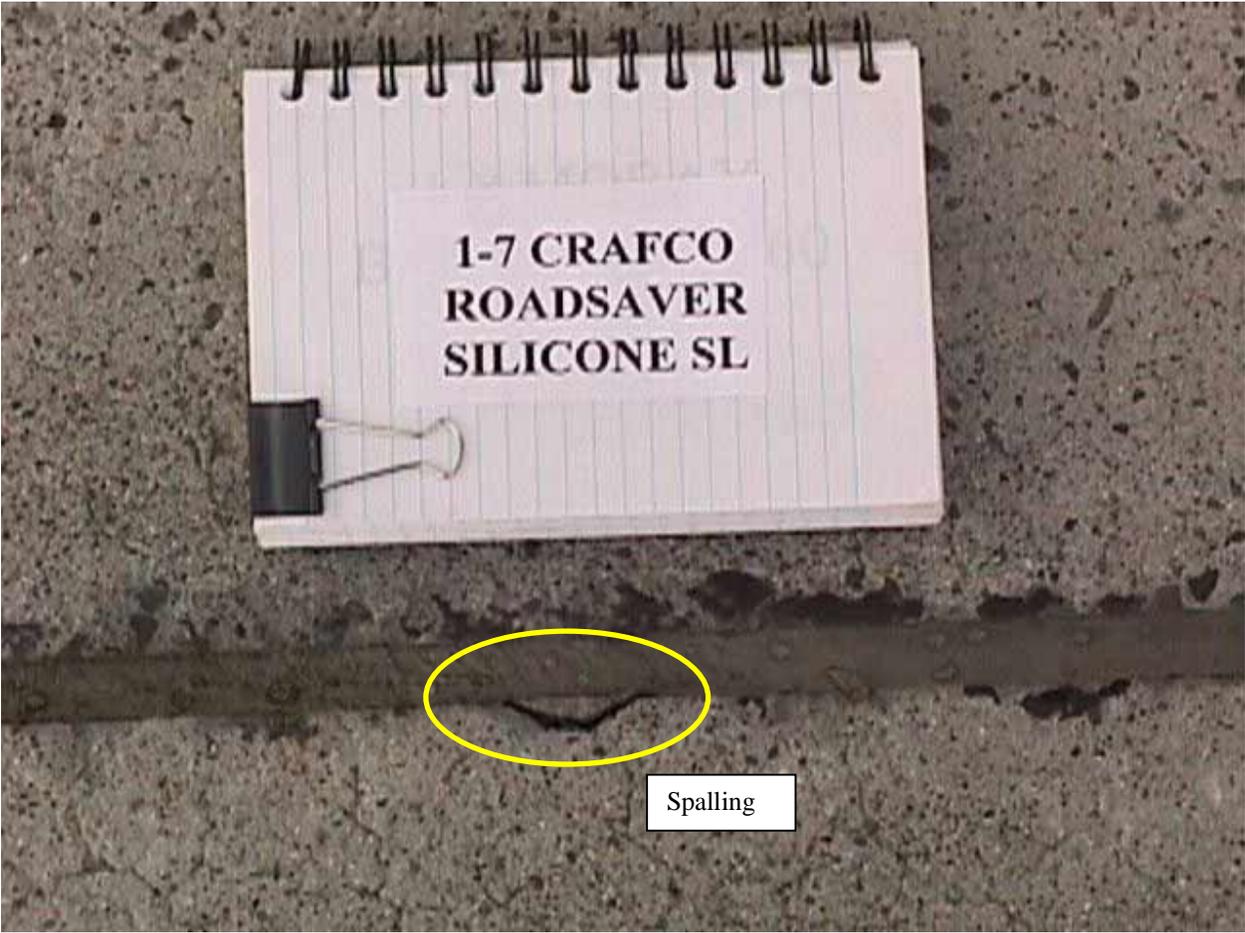
FIGURE 3 Spalling Associated With The Silicone Sealant
