# Technical Memorandum

## Arizona SPS-2 PCC Joint Seal Performance

The Arizona Special Pavement Studies (SPS) 2 jointed concrete pavement test site, located on eastbound I-10 between mileposts 106 and 109 was constructed in 1993 with 12 LTPP and 9 ADOT test sections. Each test section includes about 33 transverse joints, spaced at 15 ft, which were reportedly sealed using Crafcro 34902 non-sag RoadSaver Silicone sealant. Various combinations of base type, concrete strength, slab width, and slab thickness, as shown below, were designed to allow statistical analysis of the contributions of each factor. A March 2013 evaluation of the condition of the joints and seals indicates correlations of base type and Portland cement concrete (PCC) strength with adhesion and sliver spall failures.

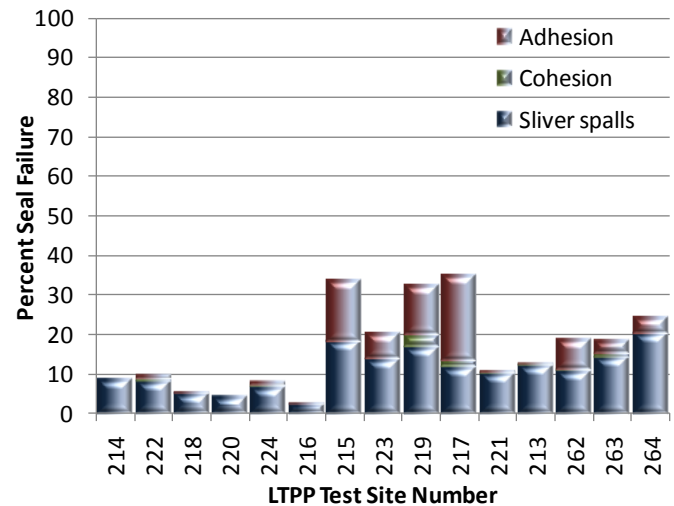
Overall performance of the SPS-2 joint seal systems is extraordinarily good, considering the seals have been in place for 20 years and the truck lane has carried about 31 million Equivalent Single Axle Loads (ESALs). As figure 1 illustrates, no section exhibits more than 35 percent overall seal failure with six sections remaining below ten percent. Five randomly-selected transverse joints were evaluated in each section.

Figure 1. Overall failure rates on transverse joints

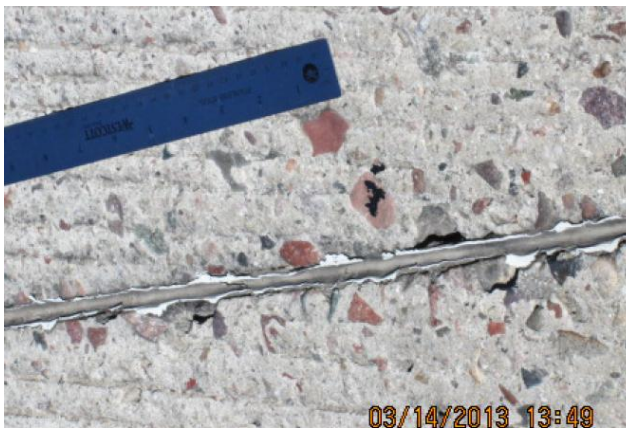
Primary modes of failure include sliver spalls and loss of adhesion with the joint walls. Additionally, slight cohesive failure was identified when the installed seal thickness (less than 0.125 in) fell below the design thickness (0.25 in). Full depth sliver spalls, shown in figure 2, typically progress around or through the aggregate adjacent to the joint wall.

These sliver spalls accounted for more than 65 percent of the seal system failures with 2.4 times more failure noted in 550 psi than the 900 psi compressive strength

Figure 2. Spall failure – transverse joint (section 264).

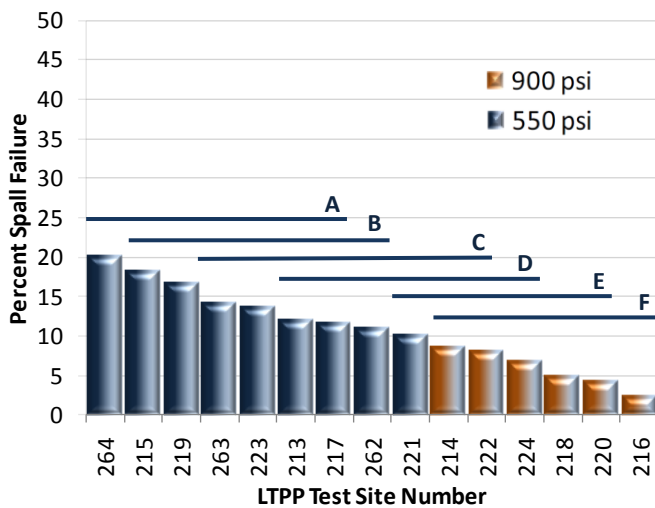
concrete. Figure 3 illustrates this trend, showing statistically similar failure rates under each Duncan grouping bar. Most likely the increased spall failure with decreased concrete strength results from the effect of the non-relaxing stresses induced on the concrete face by the silicone seals as the joint opens. The weaker mortar found in the lower strength concrete is less able to resist this stress, particularly when shear stresses are induced by passing truck tires, resulting in increased spall formation.

Figure 3. Sliver spall failure rates on transverse joints.

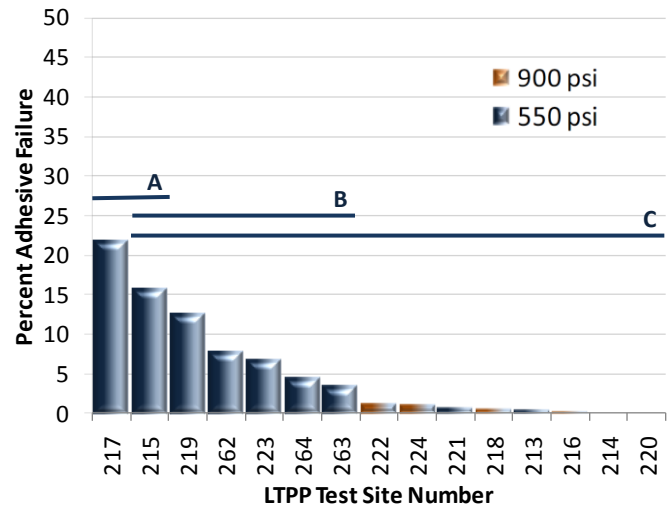
Concrete strength also affected the rate of adhesive failure (see figure 4). Twenty times more adhesive loss occurred in the 500 psi sections than for the 900 psi concrete. Field observations reveal frequent granules of sand and aggregate adhered to the seal edges following adhesive failure. This indicates that weaker mortar, combined with sustained stress at the seal-concrete

Figure 4. Adhesive failure on transverse joints

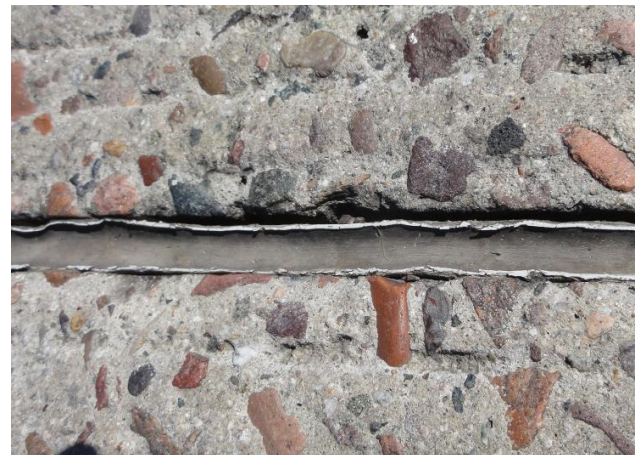
bond, resulted in additional adhesive failure. Figure 5 demonstrates this type of adhesive failure. Notice the exposed large aggregate on the surface, indicative of weaker mortar with less resistance to stress.

Figure 5. Adhesive failure – transverse joint (sect. 215)

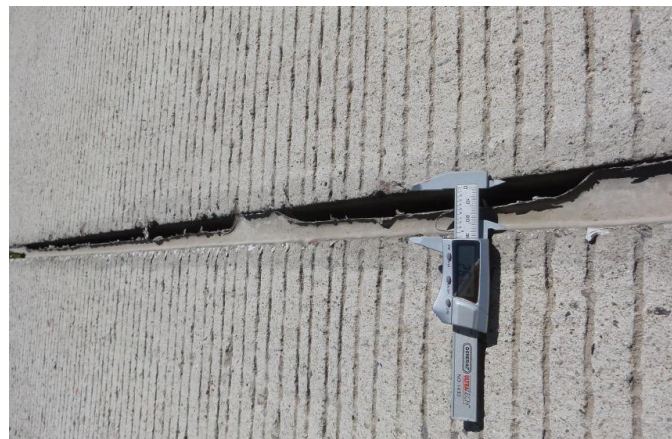
These increases can be explained by the frequent widening of the original 0.375-in joint to more than 1.0-in width. Such extreme increased extensions exceed the typical 25 percent silicone seal design limits. It is

therefore surprising that many seals (figure 7) have extended to more than 300 percent and remain partially bonded.

Figure 7. Adhesive failure on longitudinal joints.

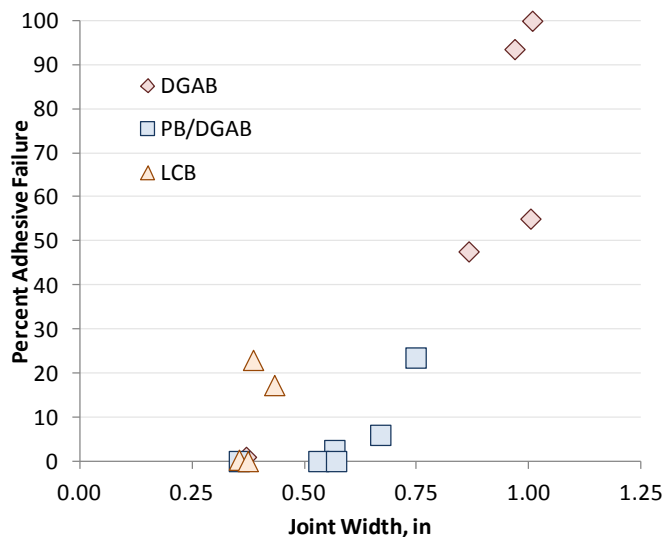
As figure 8 illustrates, adhesive failure increases about 12 percent for every 0.1 in of increased longitudinal joint width. This figure also reveals an effect of base type on joint width, and hence on adhesion failure. On average, longitudinal joints over the 6-in DGAB widened 2.7 times. Joints in concrete overlying 4-in permeable bituminous treated base (PB) and 4-in DGAB were widened 1.8 times, and those over lean concrete base (LCB) increased 1.2 times on the day of testing. Adhesion failure rates increased accordingly.

Figure 8. Overall failure on longitudinal joints.

This trend can be expected since typical horizontal friction levels between PCC and cement or asphalt stabilized bases triple those of DGAB. Current practices of tying concrete shoulders to traffic lanes will alleviate this extreme movement and resulting seal failure.

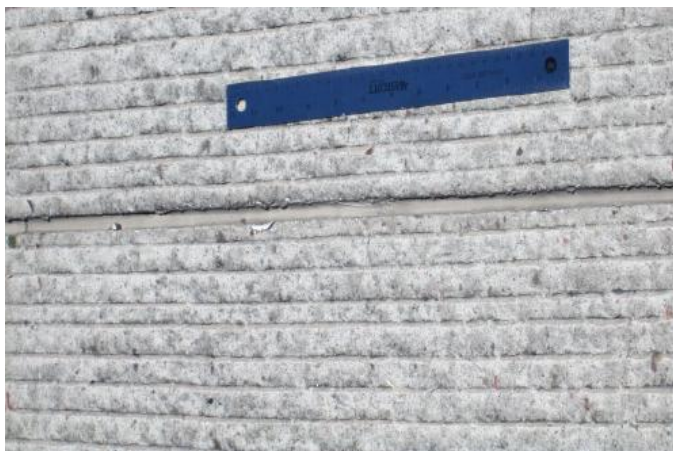
Silicone seals in the transverse joints of the Arizona SPS-2 site remain in excellent condition, affected primarily by the strength properties of the concrete pavement. Figure 9 provides an example of high performing seal from section 222. Average adhesion failure rates of 5 percent after 20 years indicate high quality materials and installation practices.

Figure 9. Transverse joint seal in section 222.

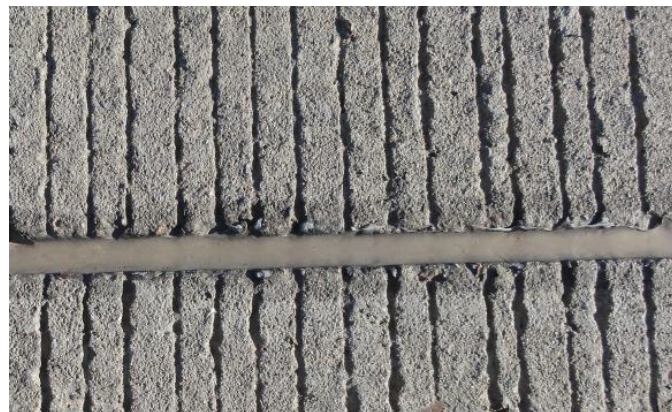
Silicone seal effectiveness on longitudinal joints ranged from 0 to 100 percent, averaging 41 percent. Figure 10 illustrates good seal performance in a 900 psi concrete over PB/DB base.

Figure 10. Longitudinal joint seal in section 222.
