# Measured Effects of Joint and Crack Sealing

2000 M&RR 01

# Sealing Concrete Shoulder-Joints

# Crack Sealing Hot Mix Asphalt

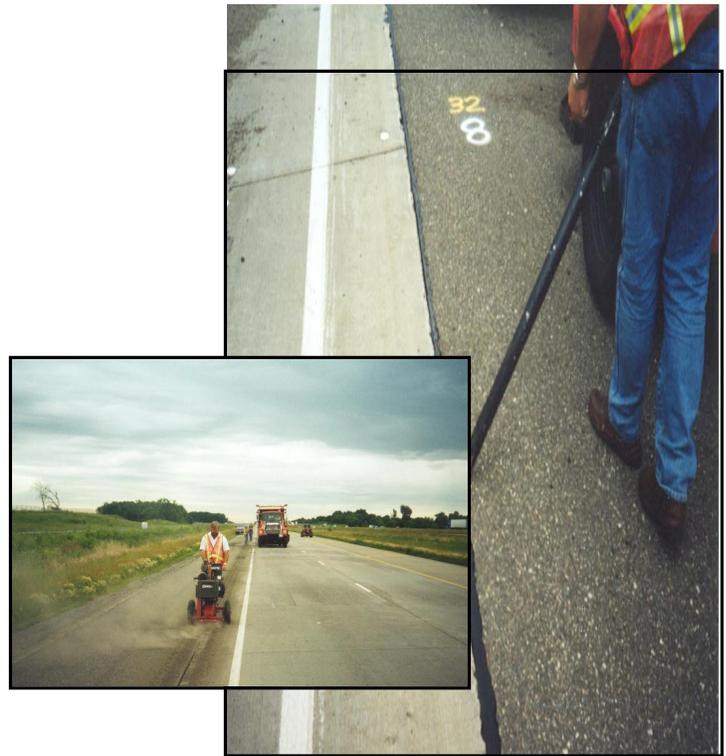
The joint sealing study, conducted on drained concrete test sections at the Mn/ROAD site, involves looking at pavement drainage in response to single rain events; both before and after the shoulder joint is sealed. Precipitation data is collected from an on-site weather station while drainage data is collected using tipping buckets installed at the headwall of the edge drain outlets. Data collected before and after the joint sealing is presented in the graph below. Additionally, two precipitation events similar in volume and intensity are compared (Table 1). Initial results indicate that sealing the edge joint on concrete pavements reduces the volume of water drained through the edge drains by as much as 85%. These findings suggest that one of the primary sources of infiltration into the pavement system is through the edge joint. Therefore, it may be cost effective to seal joints to prevent infiltration, and thus reduce the potential for shoulder settlement, pavement deterioration and distress. ◀

Sealing the edge joint on the test section consisted of routing a 3/4" x 3/4" reservoir on the asphalt shoulder adjacent to the PCC edge. After clearing the reservoir of any debris it was filled with a MN/DOT specification 3725 sealant. In this case Crafc0 522.

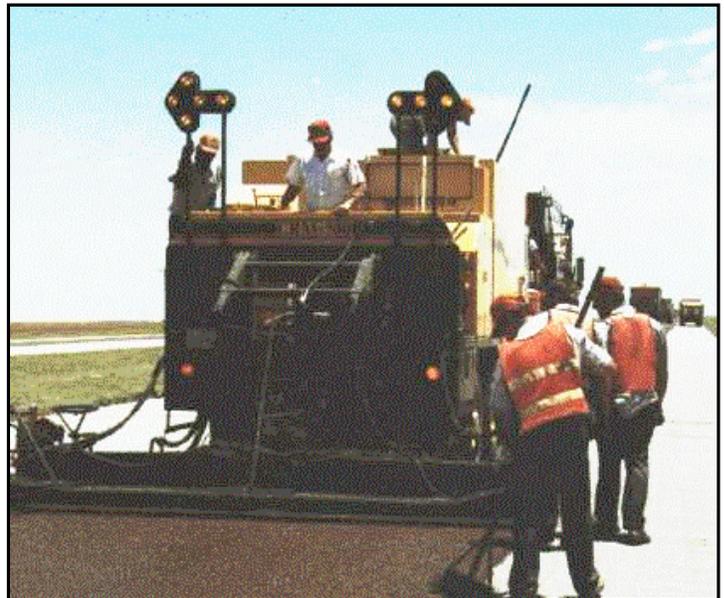
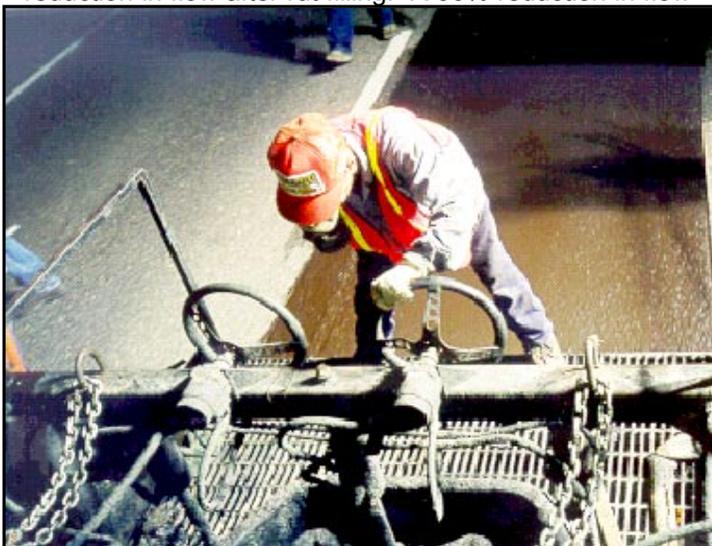
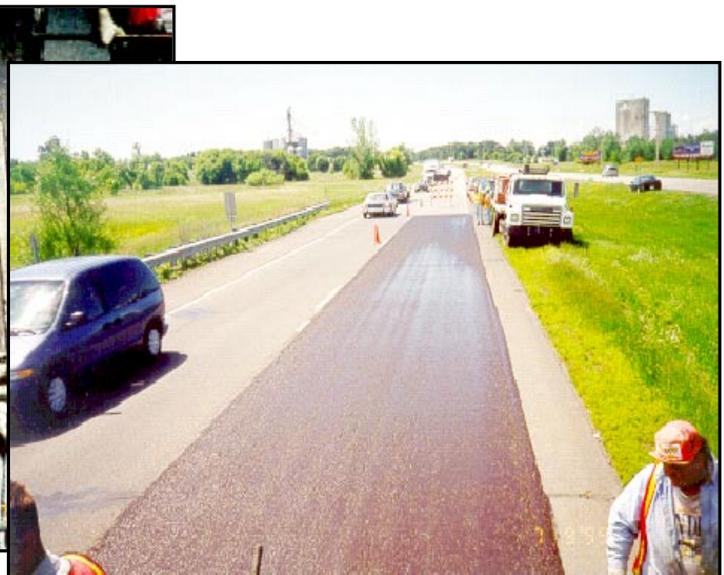
Table 2. Before and After Microsurfacing

Cell 23, which consists of 8.75 inches of HMA over 4 inches of Permeable Asphalt Stabilized Base (drainable base) has tipping buckets in place to measure the outflow of moisture from the pavement system. Tipping buckets record the number of tips within a 15 minute interval. With the application of the microsurfacing treatment, there was the opportunity to determine the reduction of moisture infiltration into the pavement system. The results from single rain events of similar intensity, both before and after the microsurfacing treatment, are presented (Table 2). There was an 83% reduction in flow after rut filling. A 90% reduction in flow

Date	Event Volume (mm)	Event Intensity (mm/hr)	Volume Drained (liters)
July 3	25.9	9.4	531
<b>July 7</b>	<b>Rut Filling</b>		
July 25	31.8	14.0	90
<b>August 13</b>	<b>Surface Course</b>		
August 22	58.4	11.1	119

Microsurfacing consisted of placing a rut fill and surface course as a pavement preservation treatment. In this case, to correct rutting. The microsurfacing treatment in this study is viewed as a crack sealing experiment.
