Impact of Sealed Joints on Performance of Thin Whitetopping at MnROAD

Transportation Research Board 91st Annual Meeting
January 25th, 2012

Tom Burnham, P.E.
Minnesota Department of Transportation

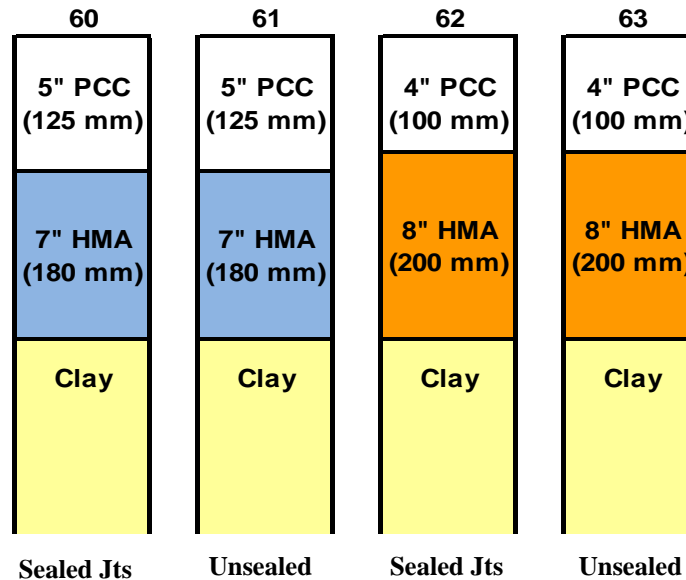
MnROAD Test Sections (2004)

- Cells 60 and 62 constructed with single saw cut joints filled with hot-pour asphalt sealant
- Cells 61 and 63 constructed with no sealant
- Panel size = 5 ft. L x 6 ft. W [1.52 m L x 1.83 m]

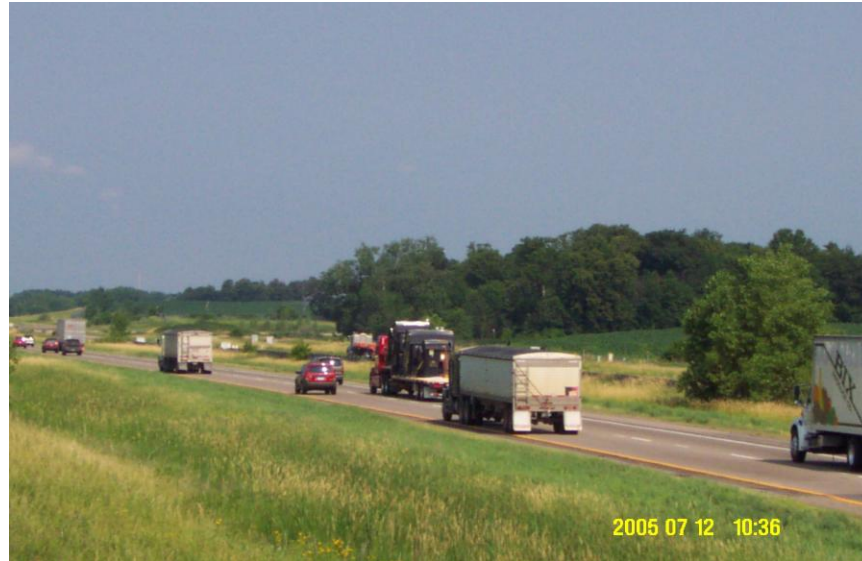
Traffic

- I-94 live interstate traffic
- “Accelerated” loading for 4” and 5” PCC
- CESAL’s 2004-2011 = 6.5 million

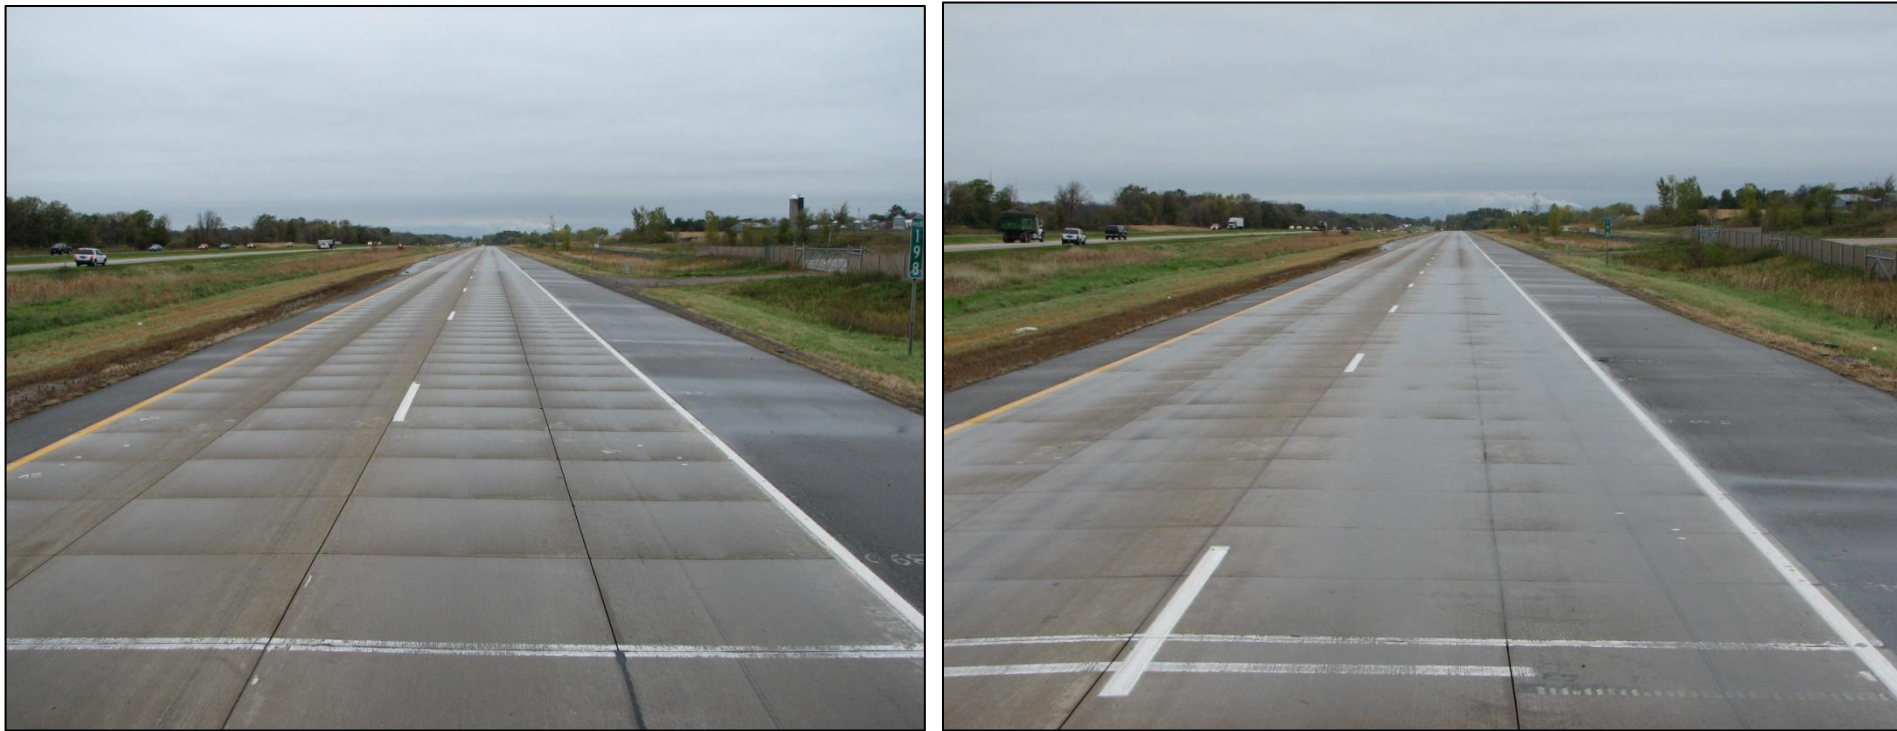
Performance

Sections with sealed/filled joints performed better!

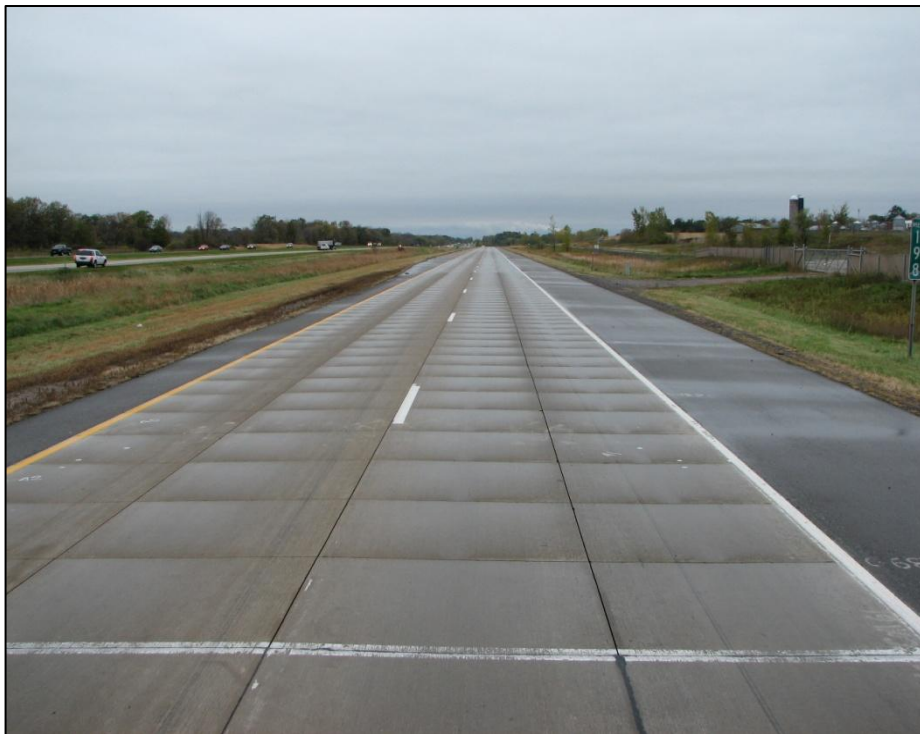
Unsealed Joints

4" PCC = 55% cracked panels

5" PCC = 8% cracked panels

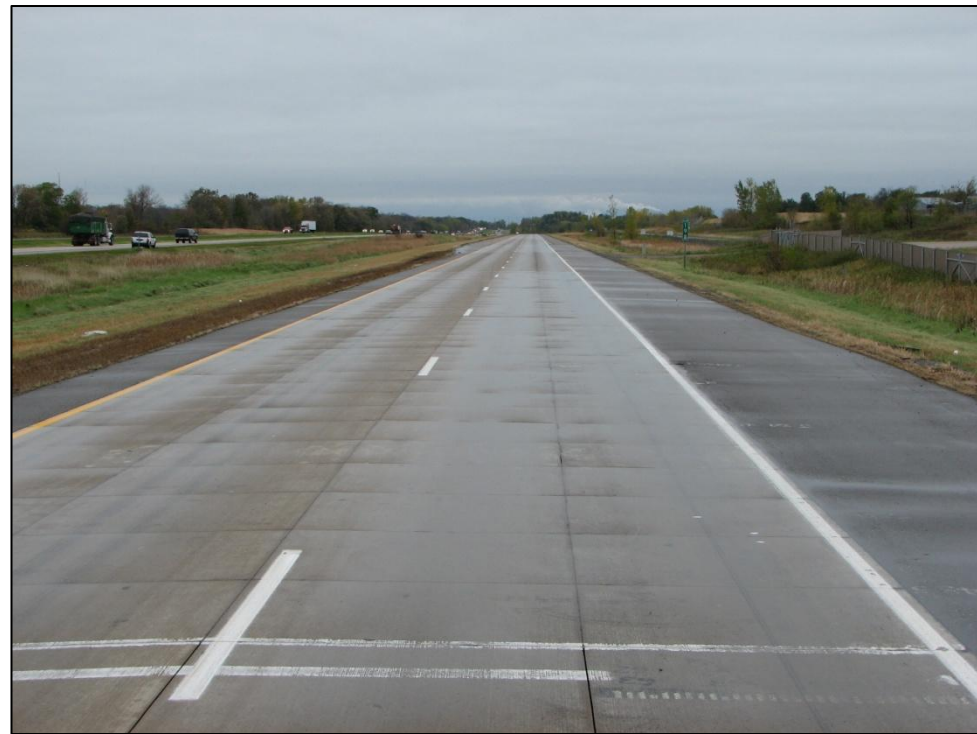
Sealed Joints

4" PCC = 11% cracked panels

5" PCC = 11% cracked panels

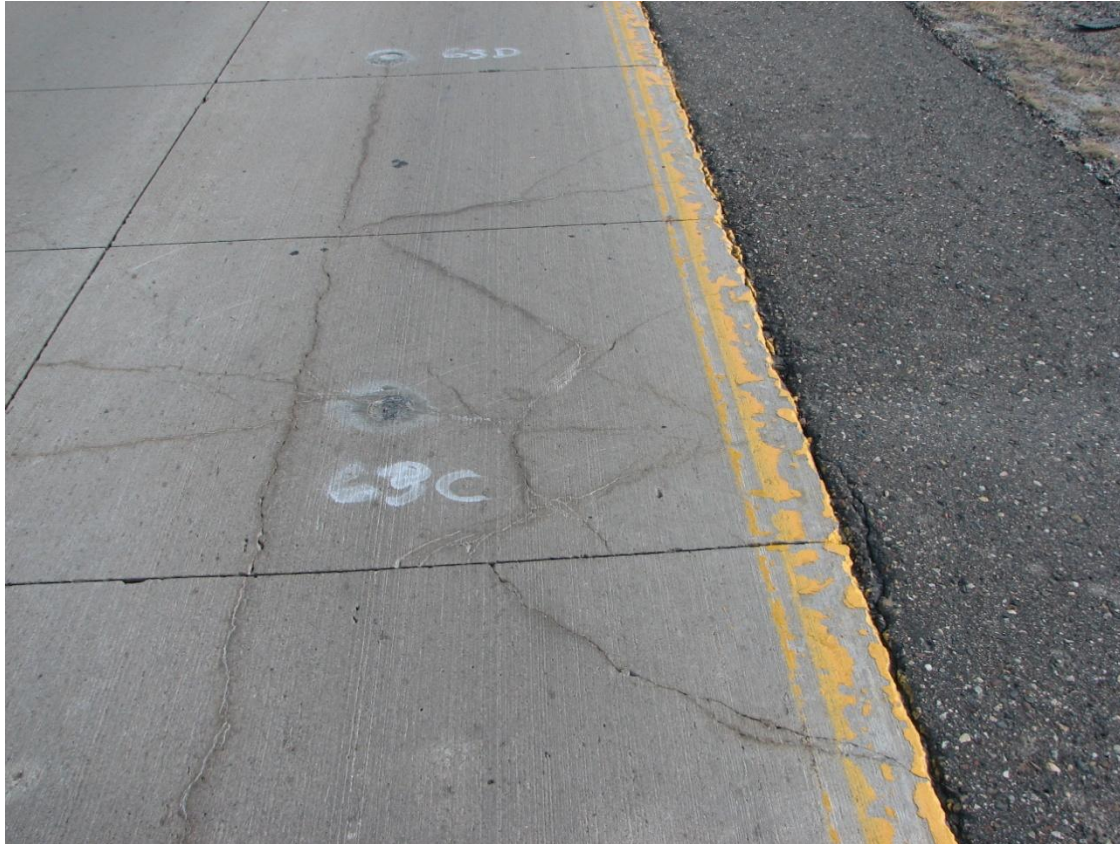
Cell 63 (Fall 2010)

4 inch PCC with unsealed joints

Cracked and “shattered” panels

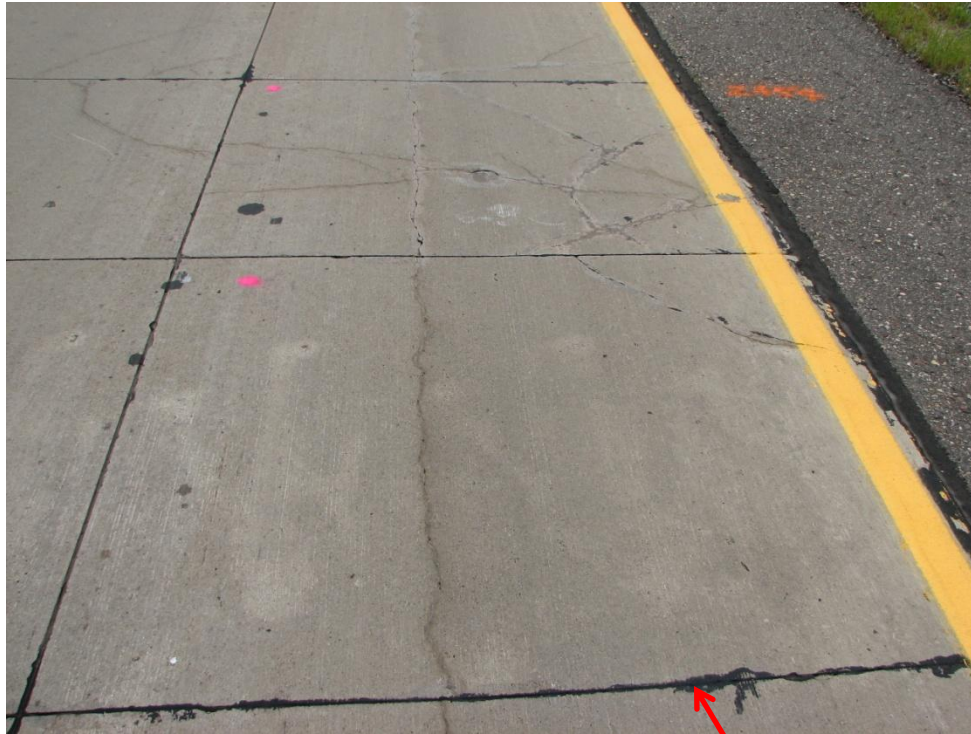
Cell 63 (Spring 2011)

4 inch PCC with unsealed joints

Joints sealed in Fall 2010 to slow deterioration

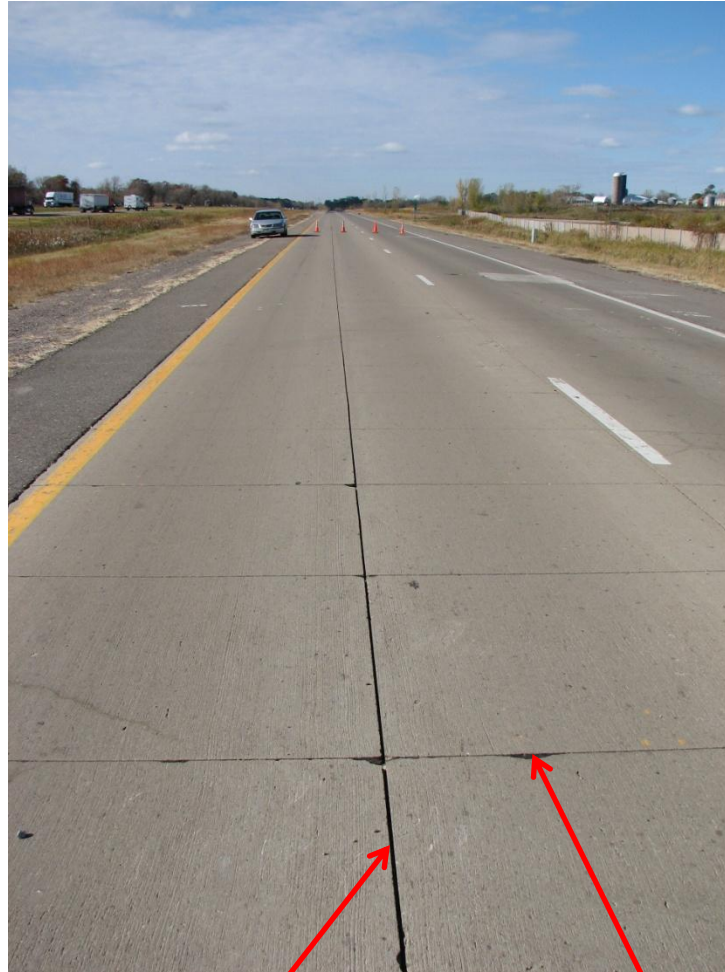
Cell 63 (2010)

4 inch PCC with unsealed joints

Widening joints

Spalling

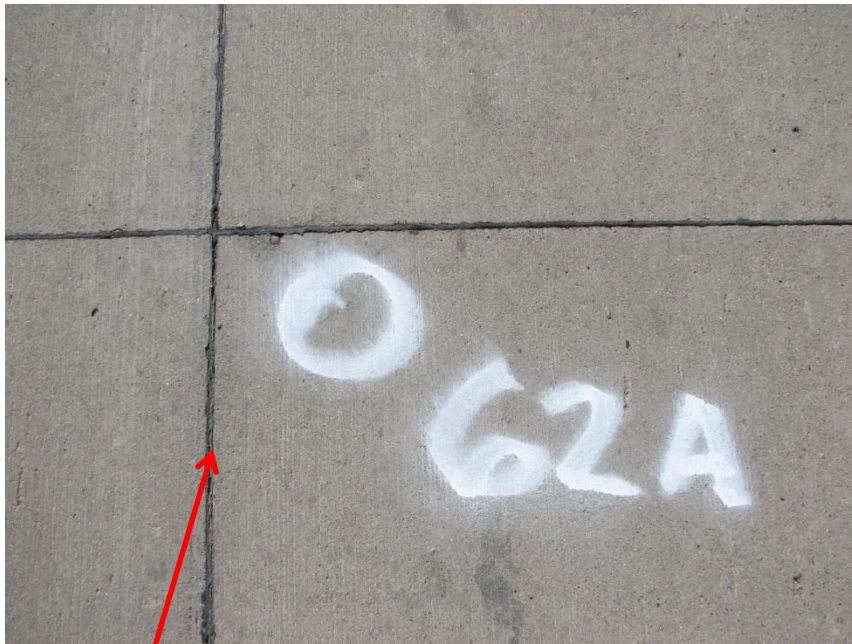
Cell 62 (2010)

4 inch PCC with sealed joints

“Tight” joints (virtually no spalling)

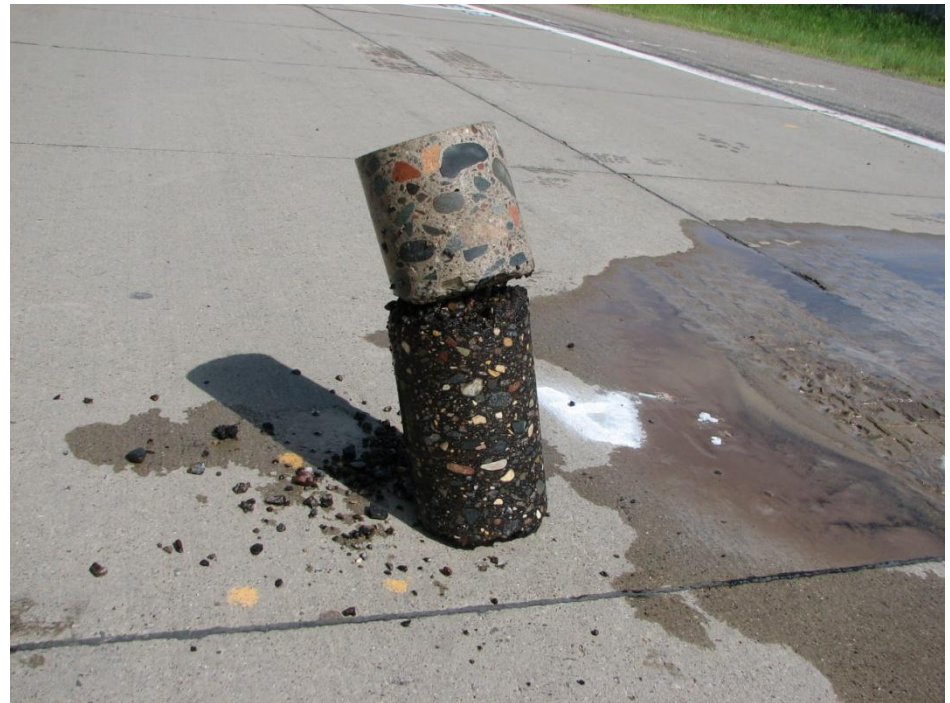
Unbonded, with some HMA deterioration

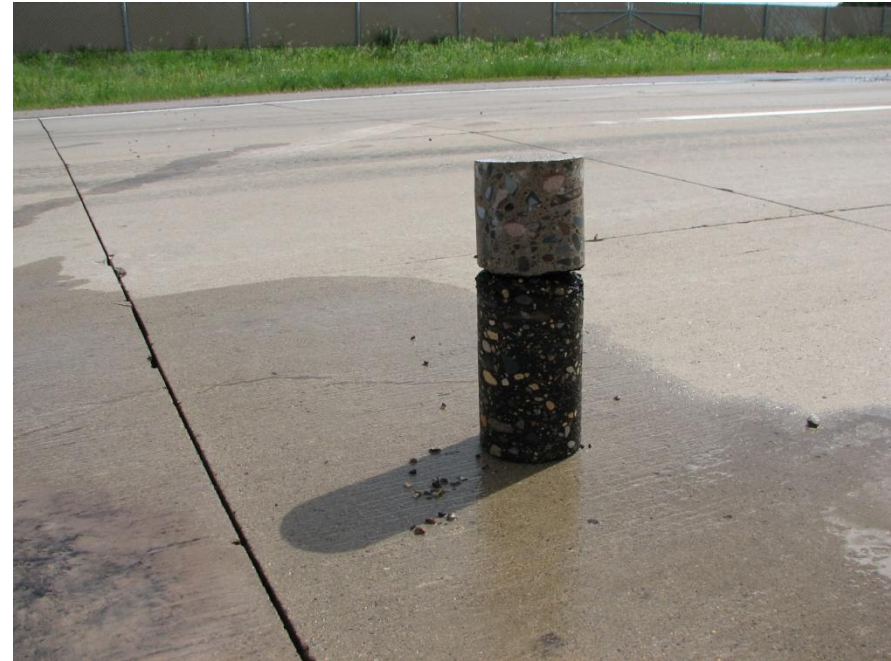
Unbonded, with some HMA deterioration

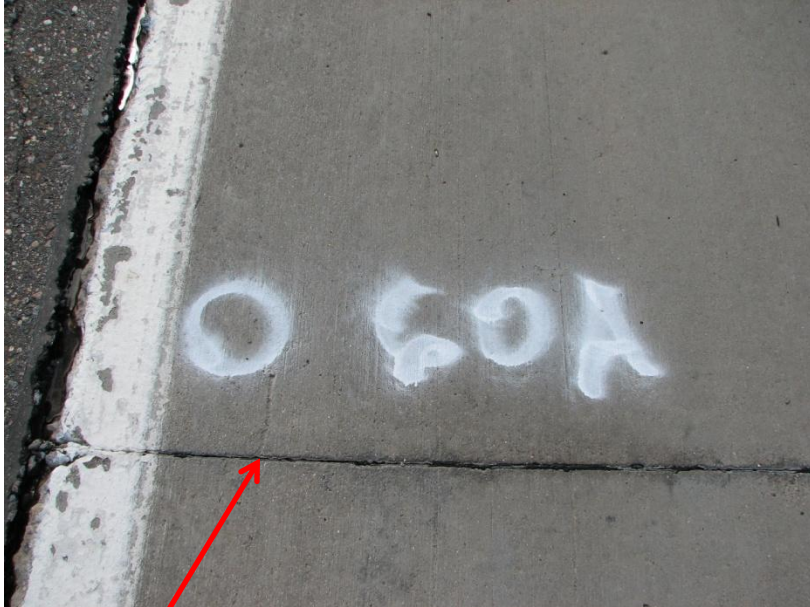
Cell 60 (2010)

5 inch PCC with sealed joints

“Tight” joints (virtually no spalling)

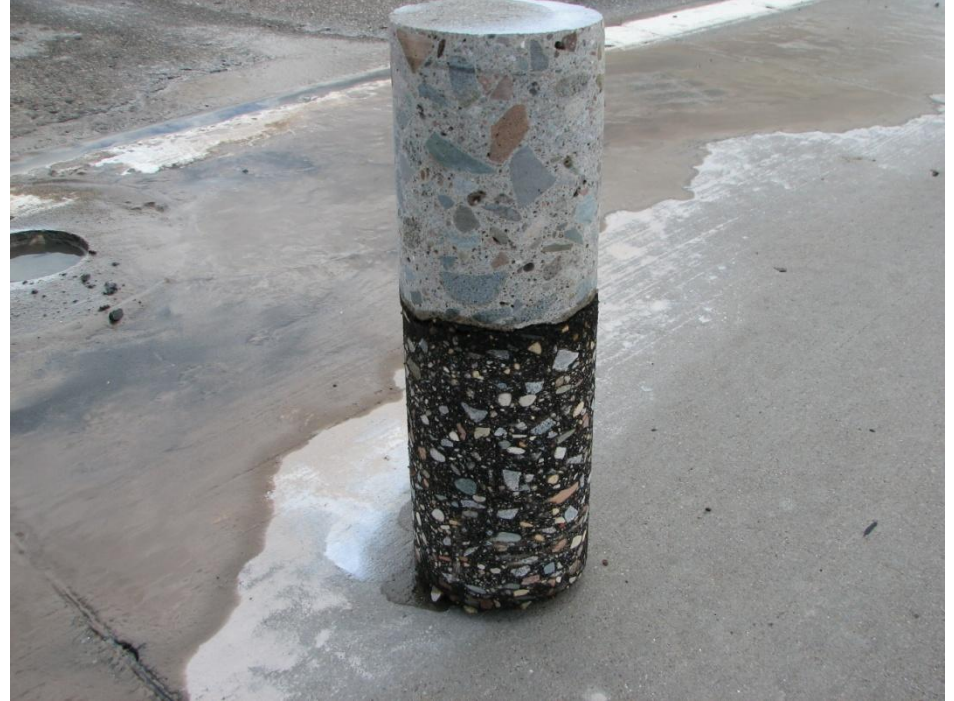
Unbonded, no HMA deterioration
