**NORTH DAKOTA
DEPARTMENT OF TRANSPORTATION**

Experimental Study MR 97-01

**Practice of Unsealed Joints in New
Portland Cement Concrete Pavements**

Final Evaluation Report

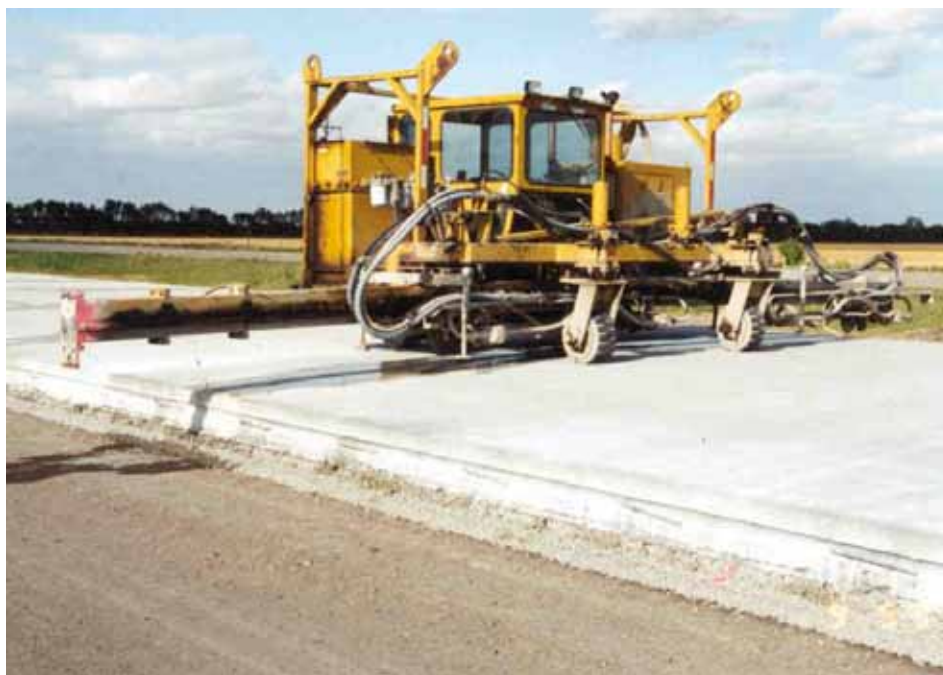
Photo 1 - Typical gang sawing machine used on project IM-6-029(027)161 in the Grand Forks District.

Materials and Research visited the project site on September 5, 1997. The contractor was in the process of sawing joints in the test section. However, it became necessary for the contractor to cease operations because the PCC was still too green. This in turn was causing the PCC to spall during the sawing operation. The contractor commented that he was very concerned about the spalling since this would be the final sawing the unsealed joints would receive. The sawing machine stayed approximately 1/2 mile behind the paving machine. The contractor was able to saw a joint across the mainline in approximately 1 minute and 15 seconds.

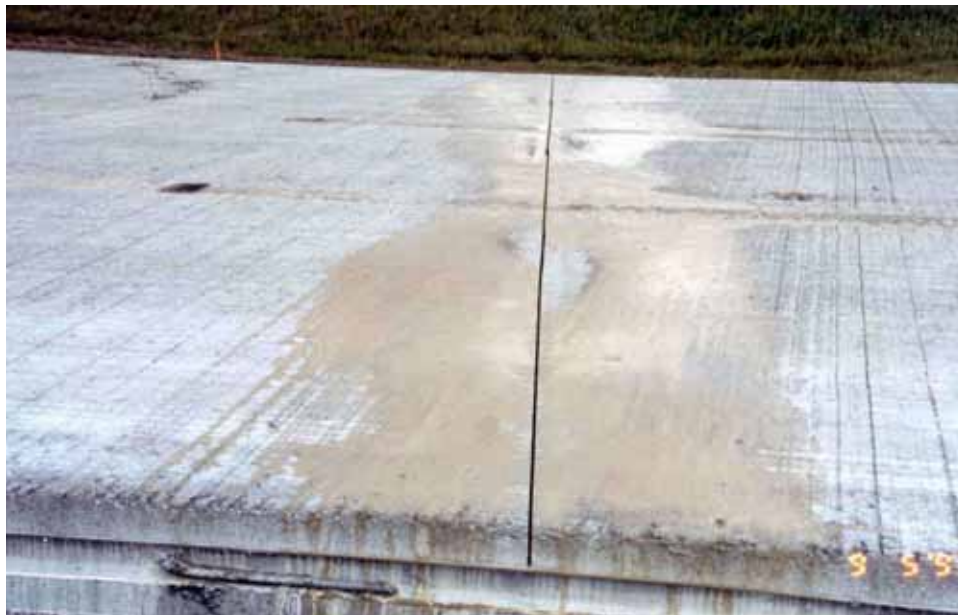
Photo 2 - Typical sawed joint.

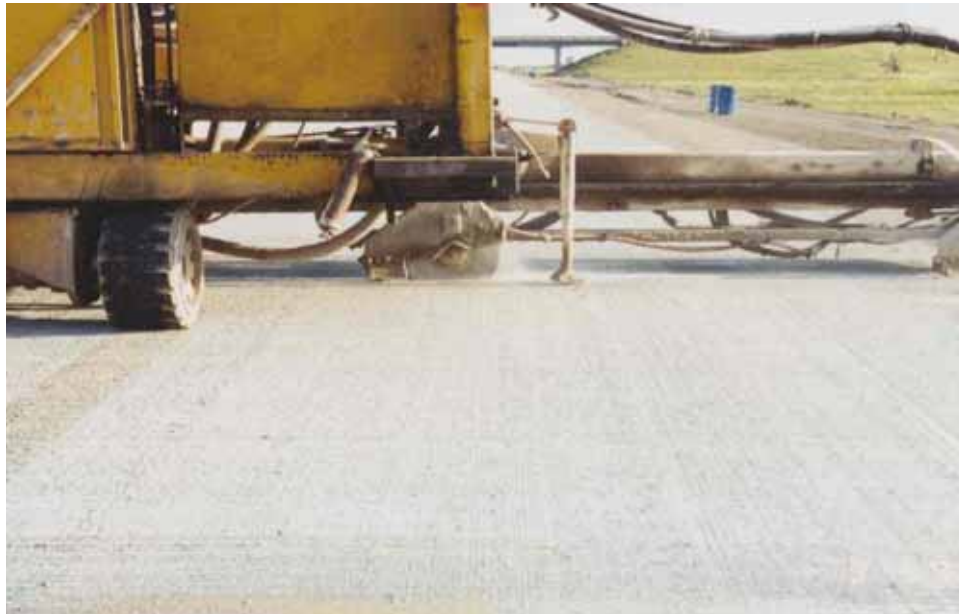
As previously mentioned the saw depth on project IM-6-029(027)161 was T/3. The PCC pavement thickness on project IM-6-029(027)161 is 10". During the joint sawing process there were some problems that developed. Photos 5 and 6 depict the sawing process as it commences from right to left. Please note that photos 5 and 6 were taken from the same location. In photo 7, the end saw overlaps an area

Photo 5 - Sawing process as it commences from right to left.

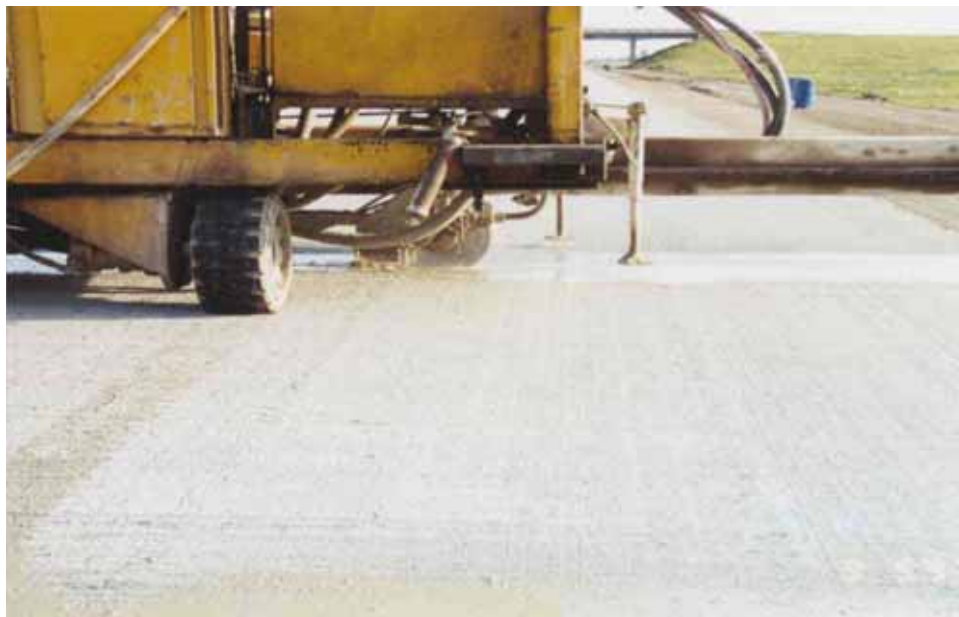
Photo 6 - Sawing process as it finishes from right to left.
