Joint Sealant Field Performance – Ten Year Evaluation

The field phase was initiated in June 1991 at Fairchild Air Force Base near Spokane, WA. The focus of this effort was to determine the field performance of field molded sealants (including improved materials versus commercially available sealants), and if field performance could be improved by changing the sealant installation geometry. Thirteen different field-molded sealants were installed and their field performance monitored at different times over a 10-year period. The evaluations indicated that two of the hot-applied, asphalt-based sealants, four of the silicone-based sealants, and one of the coal tar-based sealants had live expectancies of greater than 10 years. The improved JFR and non-JFR sealants exhibited better field performance than the standard hot-applied sealants included in the evaluation.

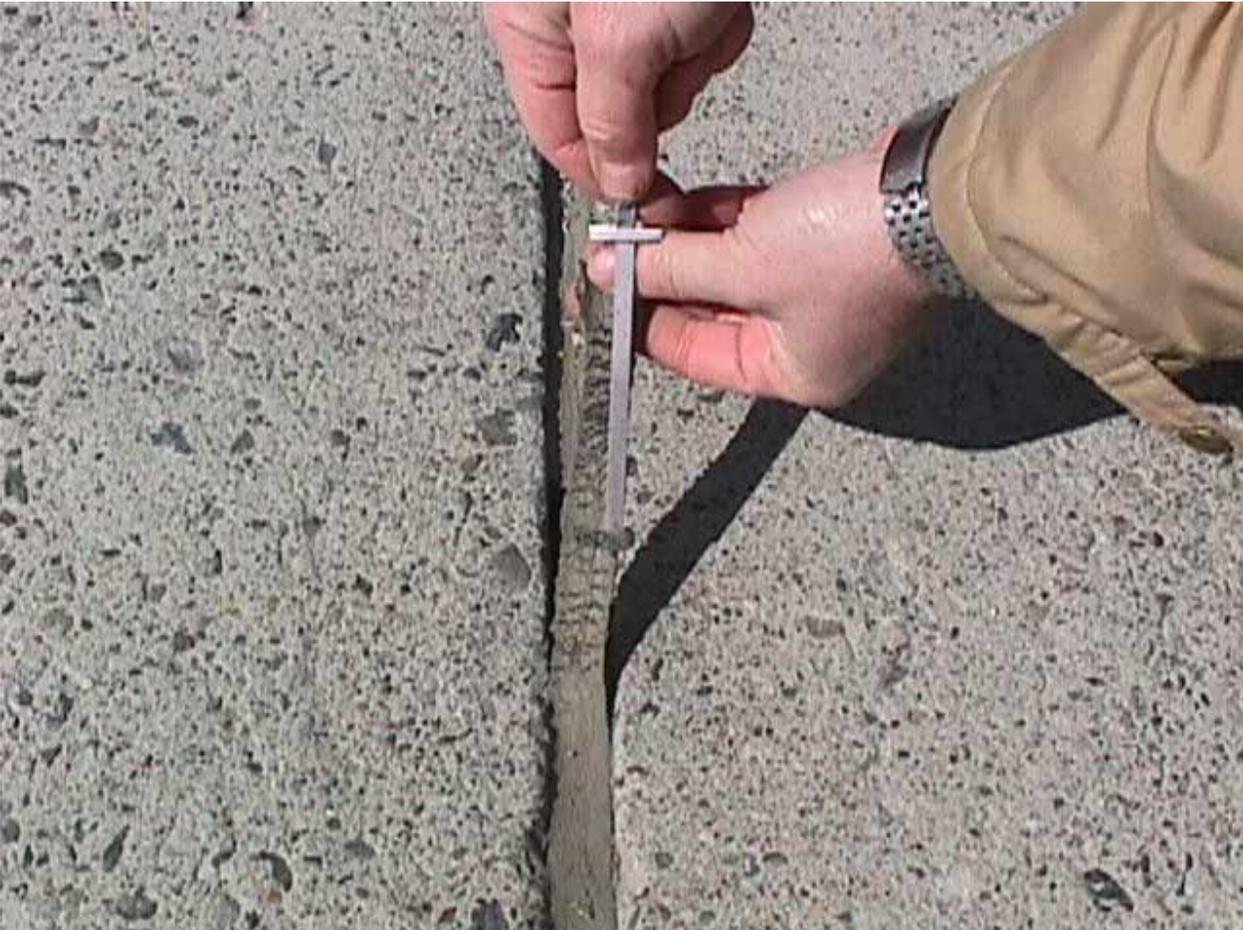
Elongation tests were conducted during the 117-month evaluation in addition to the adhesive and cohesive loss measurements. Table 5 provides a summary of the elongation results. The elongation test was conducted by cutting along both joint faces to create a section of sealant that was approximately 76 mm long. A 25.4 mm section was then marked on the sealant and the sealant was pulled perpendicular to the pavement surface until it broke or began to lose adhesion. The amount of elongation of the 25.4 mm section was measured. Figure 1 provides an illustration of an elongation test being conducted.

FIGURE 1 Conducting an Elongation Test
